## The Japanese Radiological Event at Fukushima Plant 1 (Daiichi)

Joint Meeting of the SFBAC AAPM & NCC HPS, H's Lordships, Berkeley Marina, Berkeley, CA

**April 14, 2011**

Michael P. Grissom Health Physicist

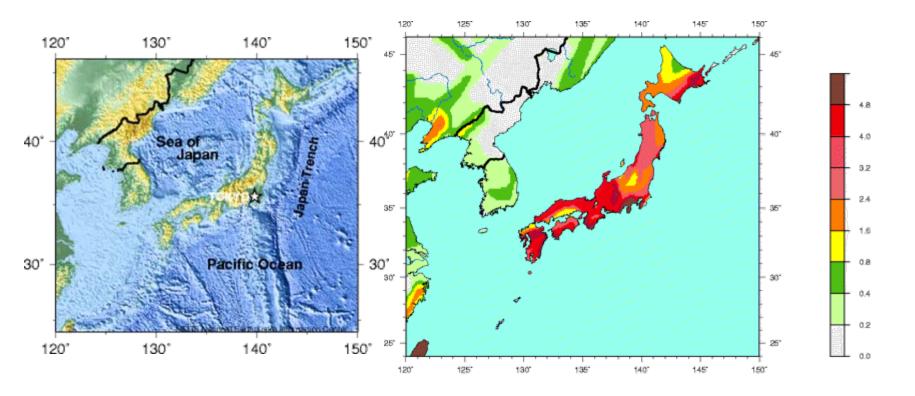
## Pacific Plate & Asian Plate Subduction Zone

Peak Ground Acceleration (m/s²) with 10% Probability of Exceedance in 50 Years

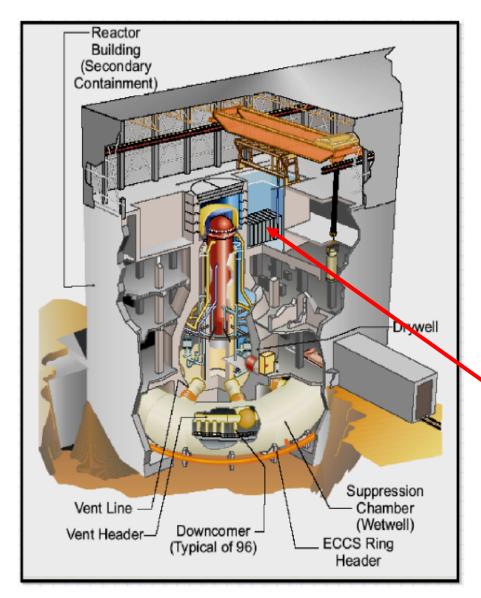
## Primary Containment Vessel Inside Containment Building

In the event of an explosion, such as from a hydrogen gas blast due to a loss of coolant accident (LOCA), the Containment Building was designed to come apart without significant damage to the much stronger built Primary Containment Vessel (PCV).

A bad practice for the very old GE BWR IIs at Daiichi (essentially 1960s technology commissioned in the early 1970s) was the 'perching' of the spent fuel pools on top of the PCV.

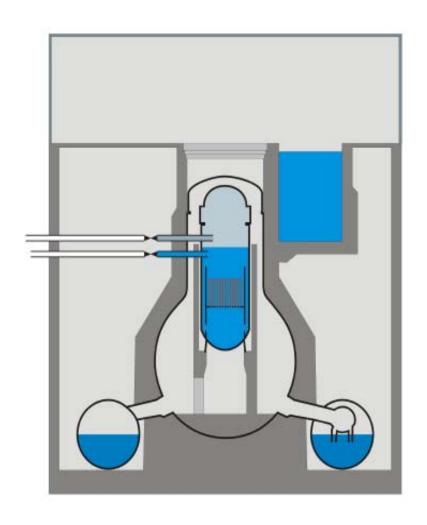
## Day 1 Earthquake (Emergency Diesels Running)

- Containment Isolation
  - Closing of all non-safety related Penetrations of the containment
  - Cuts off Machine hall
  - Due to successful containment isolation, a large early release of fission products is highly unlikely
- Diesel generators start
  - Emergency Core cooling systems are supplied
- Plant is in a stable save state

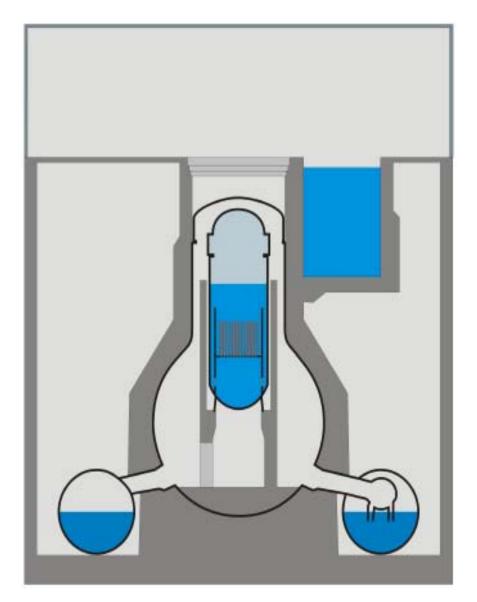
### **Day 1 Tsunami (15:01 JST)**

- ▶ 11.3. 15:01(?) Tsunami hits plant
  - Plant Design for Tsunami height of up to 5.7-6.5m
  - Actual Tsunami height 7-11m
  - Flooding of
    - Diesel and/or
    - Switchgear building and/or
    - Fuel Tanks and/or
    - Essential service water buildings
- 11.3. 15:41 Station Blackout
  - Common cause failure of the power supply
  - Only Batteries are still available
  - Failure of all but one Emergency core cooling system

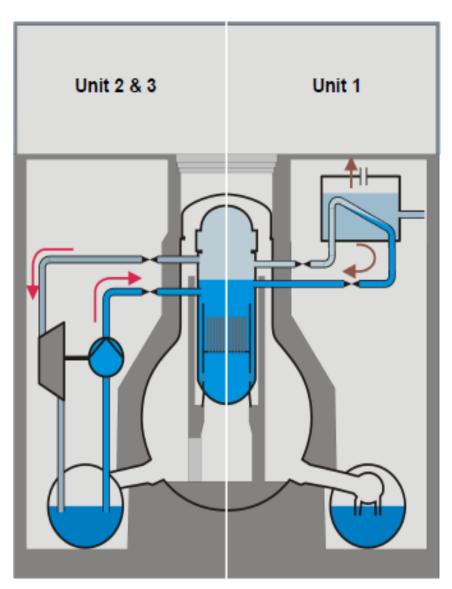
### Day 1 Tsunami (LOCA Begins)

#### Fukushima I -Unit 1

- Isolation Condenser
  - Steam enters heat exchanger
  - Condensate drains back to RPV
  - Secondary steam released from plant
- Need Pumps for Water supply
- Can't replace water in Reactor

#### Fukushima I Unit 2 & 3

- Reactor Core Isolation Pump
  - Steam from Reactor drives Turbine
  - · Steam gets condensed in Wet-Well
  - Turbine drives a Pump, pumping Water from the Wet-Well in reactor
- Necessary:
  - Battery power
  - Wet-Well Temperature < 100°C</li>
- No heat removal from the buildings

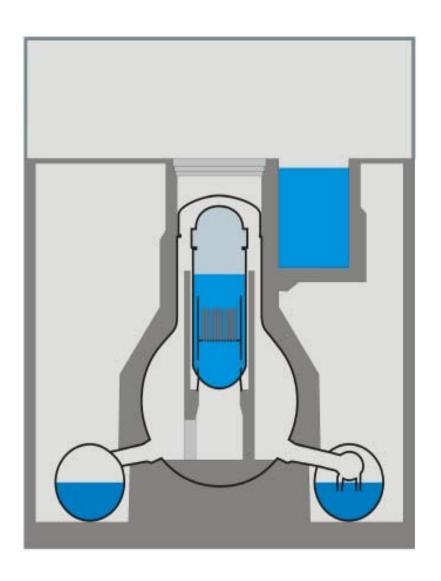
### Day 1 LOCA (Heat Crisis Starts)

- 11.3. 16:36 in Unit 1
  - Isolation condenser stops
  - Tank empty(?)
- ▶ 13.3. 2:44 in Unit 3
  - Reactor Isolation pump stops
  - Batteries empty
- 14.3. 13:25 in Unit 2
  - Reactor Isolation pump stops
  - Pump failure
- Consecutively, all reactors are cut of from any kind of heat removal

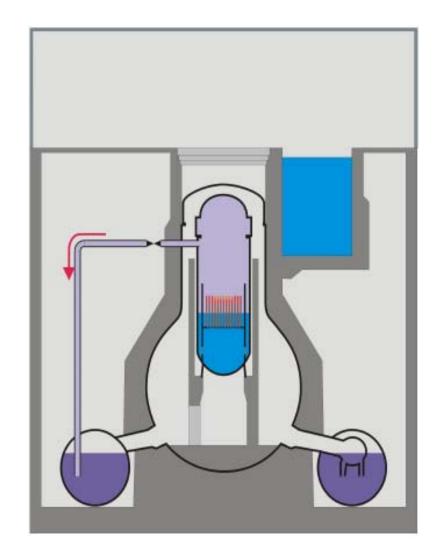
## Day 1 LOCA (Steam Buildup Drives Down Water Levels)

- ▶ ~50% of the core exposed
  - Cladding temperatures rise, but still no significant core damage
- ~2/3 of the core exposed
  - Cladding temperature exceeds ~900°C
  - Balooning / Breaking of the cladding
  - Release of fission products from the fuel rod gaps

(Measured levels are collapsed level. The actual liquid level lies higher due to the steam bubbles in the liquid)

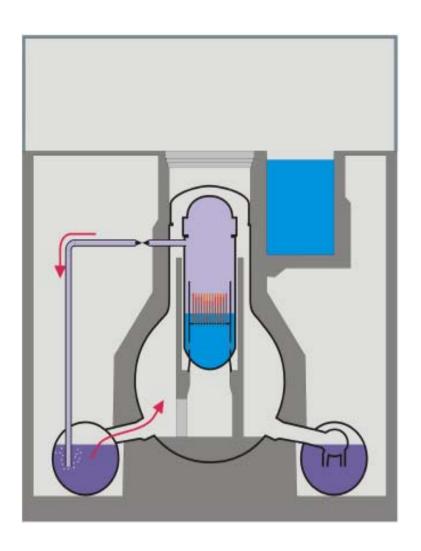
### Day 1 LOCA (Zircalloy Burns)

- ~3/4 of the core exposed
  - Cladding exceeds ~1200°C
  - Zirconium in the cladding starts to burn under steam atmosphere
  - Zr + 2H<sub>2</sub>0 ->ZrO<sub>2</sub> + 2H<sub>2</sub>
  - Exothermal reaction further heats the core
  - Estimated masses hydrogen
    - Unit 1: 300-600kg
    - Unit 2/3: 300-1000kg
  - Hydrogen gets pushed via the wet-well and the wet-well vacuum breakers into the dry-well

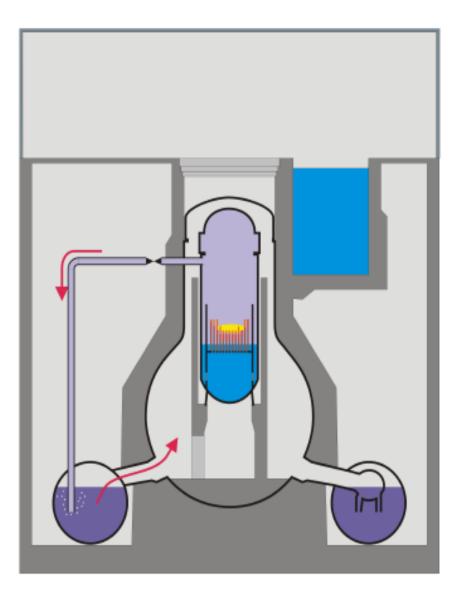
## Day 1 LOCA (Fuel Rods Rubblized)

- ▶ at ~1800°C [expected Unit 1,2,3]
  - Melting of the Cladding
  - Melting of the steel structures
- at ~2500°C [expected Unit 1,2]
  - Breaking of the fuel rods
  - debris bed inside the core
- at ~2700°C [maybe Unit 1]
  - Significant melting of Uranium-Zirconium-oxides
- Restoration of the water supply stops accident in all 3 Units
  - Unit 1: 12.3. 20:20 (27h w.o. water)
  - Unit 2: 14.3. 20:33 (7h w.o. water)
  - Unit 3: 13.3. 9:38 (7h w.o. water)

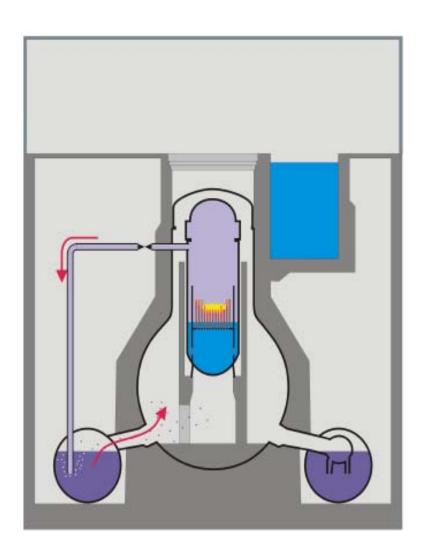
### Day 1 LOCA (Releases Escalate)

- Release of fission products during melt down
  - Xenon, Cesium, Iodine,...
  - Uranium/Plutonium remain in core
  - Fission products condensate to airborne Aerosols
- Discharge through valves into water of the condensation chamber
  - Pool scrubbing binds a fraction of Aerosols in the water
- Xenon and remaining aerosols enter the Dry-Well
  - Deposition of aerosols on surfaces further decontaminates air

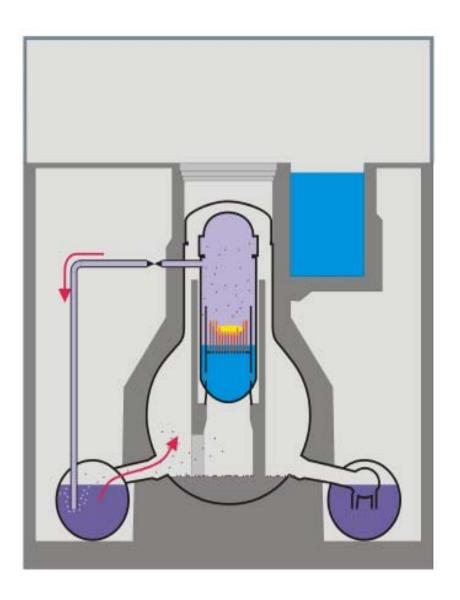
## Days 2-3 LOCA (Venting of Containment Buildings)

- Containment
  - Last barrier between Fission Products and Environment
  - Wall thickness ~3cm
  - Design Pressure 4-5bar
- Actual pressure up to 8 bars
  - Normal inert gas filling (Nitrogen)
  - Hydrogen from core oxidation
  - Boiling condensation chamber (like a pressure cooker)
- First depressurization of the containment
  - Unit 1: 12.3. 4:00
  - Unit 2: 13.3 00:00
  - Unit 3: 13.3. 8.41

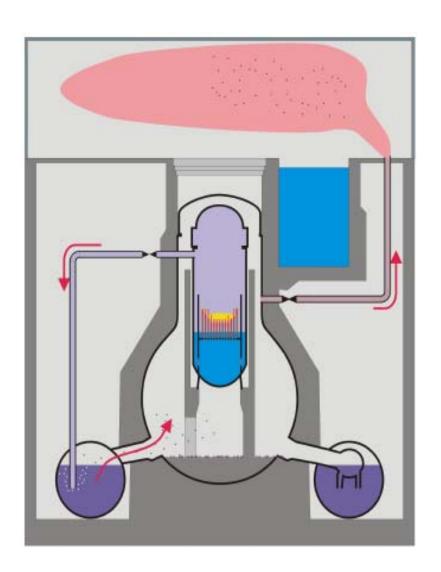
## Days 2-3 LOCA (Hydrogen Buildup Escalates)

- Positive und negative Aspects of depressurizing the containment
  - Removes Energy from the Reactor building (only way left)
  - ♦ Reducing the pressure to ~4 bar
  - Release of small amounts of Aerosols (lodine, Cesium...)
  - Release of all noble gases
  - Release of Hydrogen
- Release of unfiltered venting?
- Gas is released into the reactor service floor
  - Hydrogen is flammable

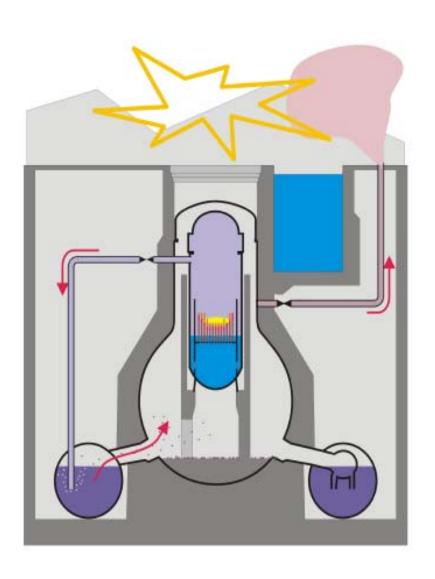
## Days 2-3 LOCA (Units 1 and 3 Hydrogen Explosions)

- Unit 1 and 3
  - Hydrogen burn inside the reactor service floor
  - Destruction of the steelframe roof
  - Reinforced concrete reactor building seems undamaged
  - Spectacular but minor safety relevant

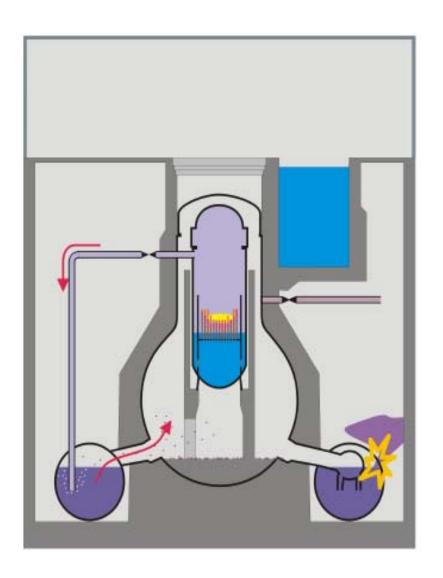
# Days 3+ LOCA (Unit 2 "Muffled" Explosion)

### Unit 2

- Probably Hydrogen leakage of the condensation chamber (actual pressure exceeds design pressure)
- Burn inside the reactor building in proximity to the wet-well
- Damage to the condensation chamber
- Uncontrolled release of
  - Gas
  - · highly contaminated water
  - Aerosols of fission products
- Temporal evacuation of the plant
- High local dose rates on the plant site due to wreckage hinder further recovery work

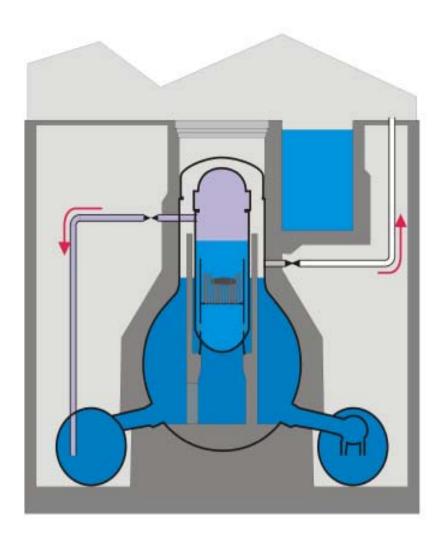
### Reactors Status 3/31/11

### Current status of the Reactors

- Core Damage in Unit 1,2, 3
- Building damage due to various burns Unit 1-4
- Reactor pressure vessels flooded in all Units with mobile pumps
- At least containment in Unit 1 flooded
- Further cooling of the Reactors
  - Unit 1: by Isolation Condensers
  - Unit 2&3: by releasing steam
- Only small further releases of fission products can be expected from Unit 2 and 3

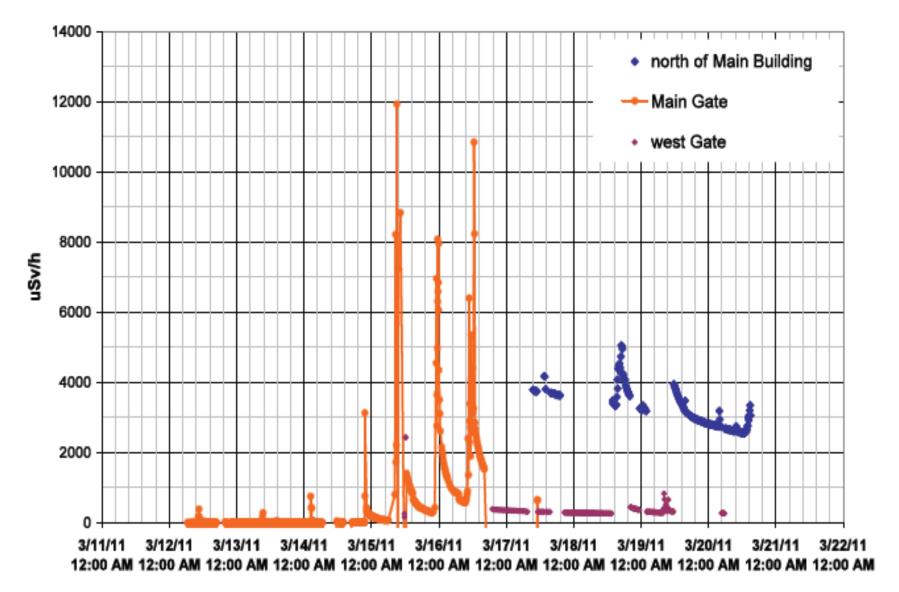
### Radiological Releases Daiichi Site 3/11-22/11 3 Locations

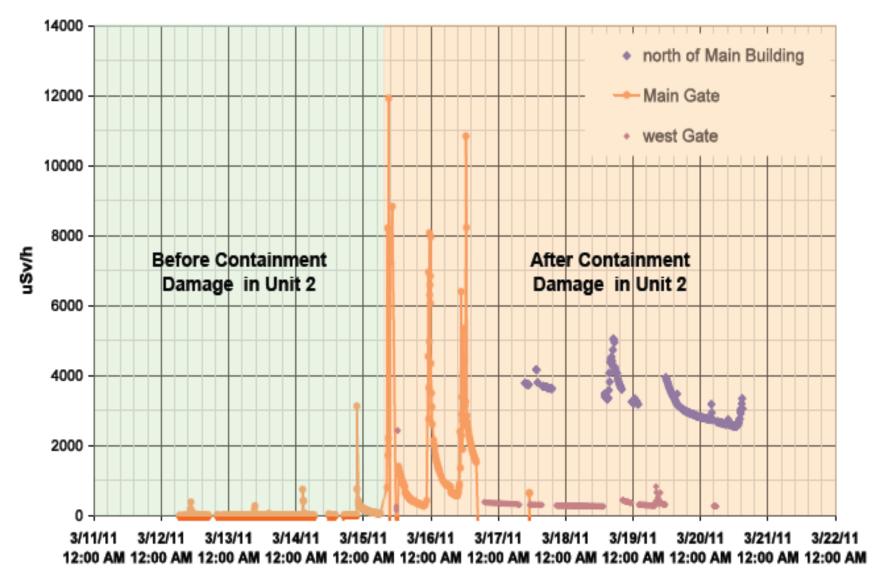
## Radiological Releases Daiichi Site 3/11-22/11 Unit 2

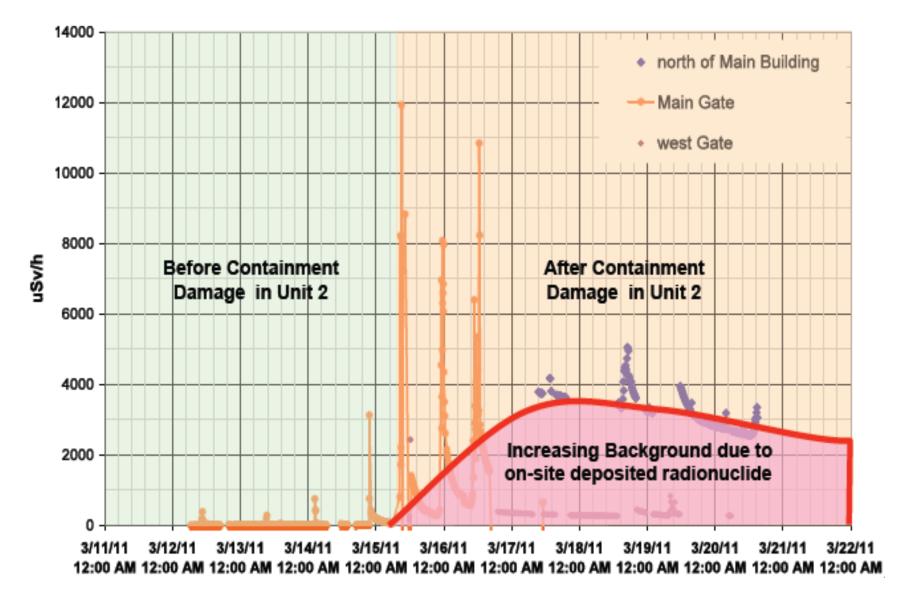
## Radiological Releases Daiichi Site 3/11-22/11 Contaminated Debris

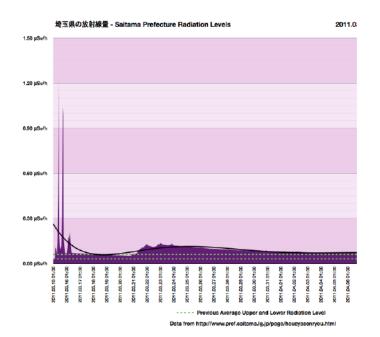
### Radiation Levels for Tokyo, Chiba, Saitama, Ibaraki
