'''||| **2020 Postclosure Groundwater Monitoring and Inspection Report, Central Nevada Test** Area, Subsurface Corrective **Action Unit 443** February 2023 Approved for public release; further dissemination unlimited U.S. DEPARTMENT OF ENERGY | Legacy Management

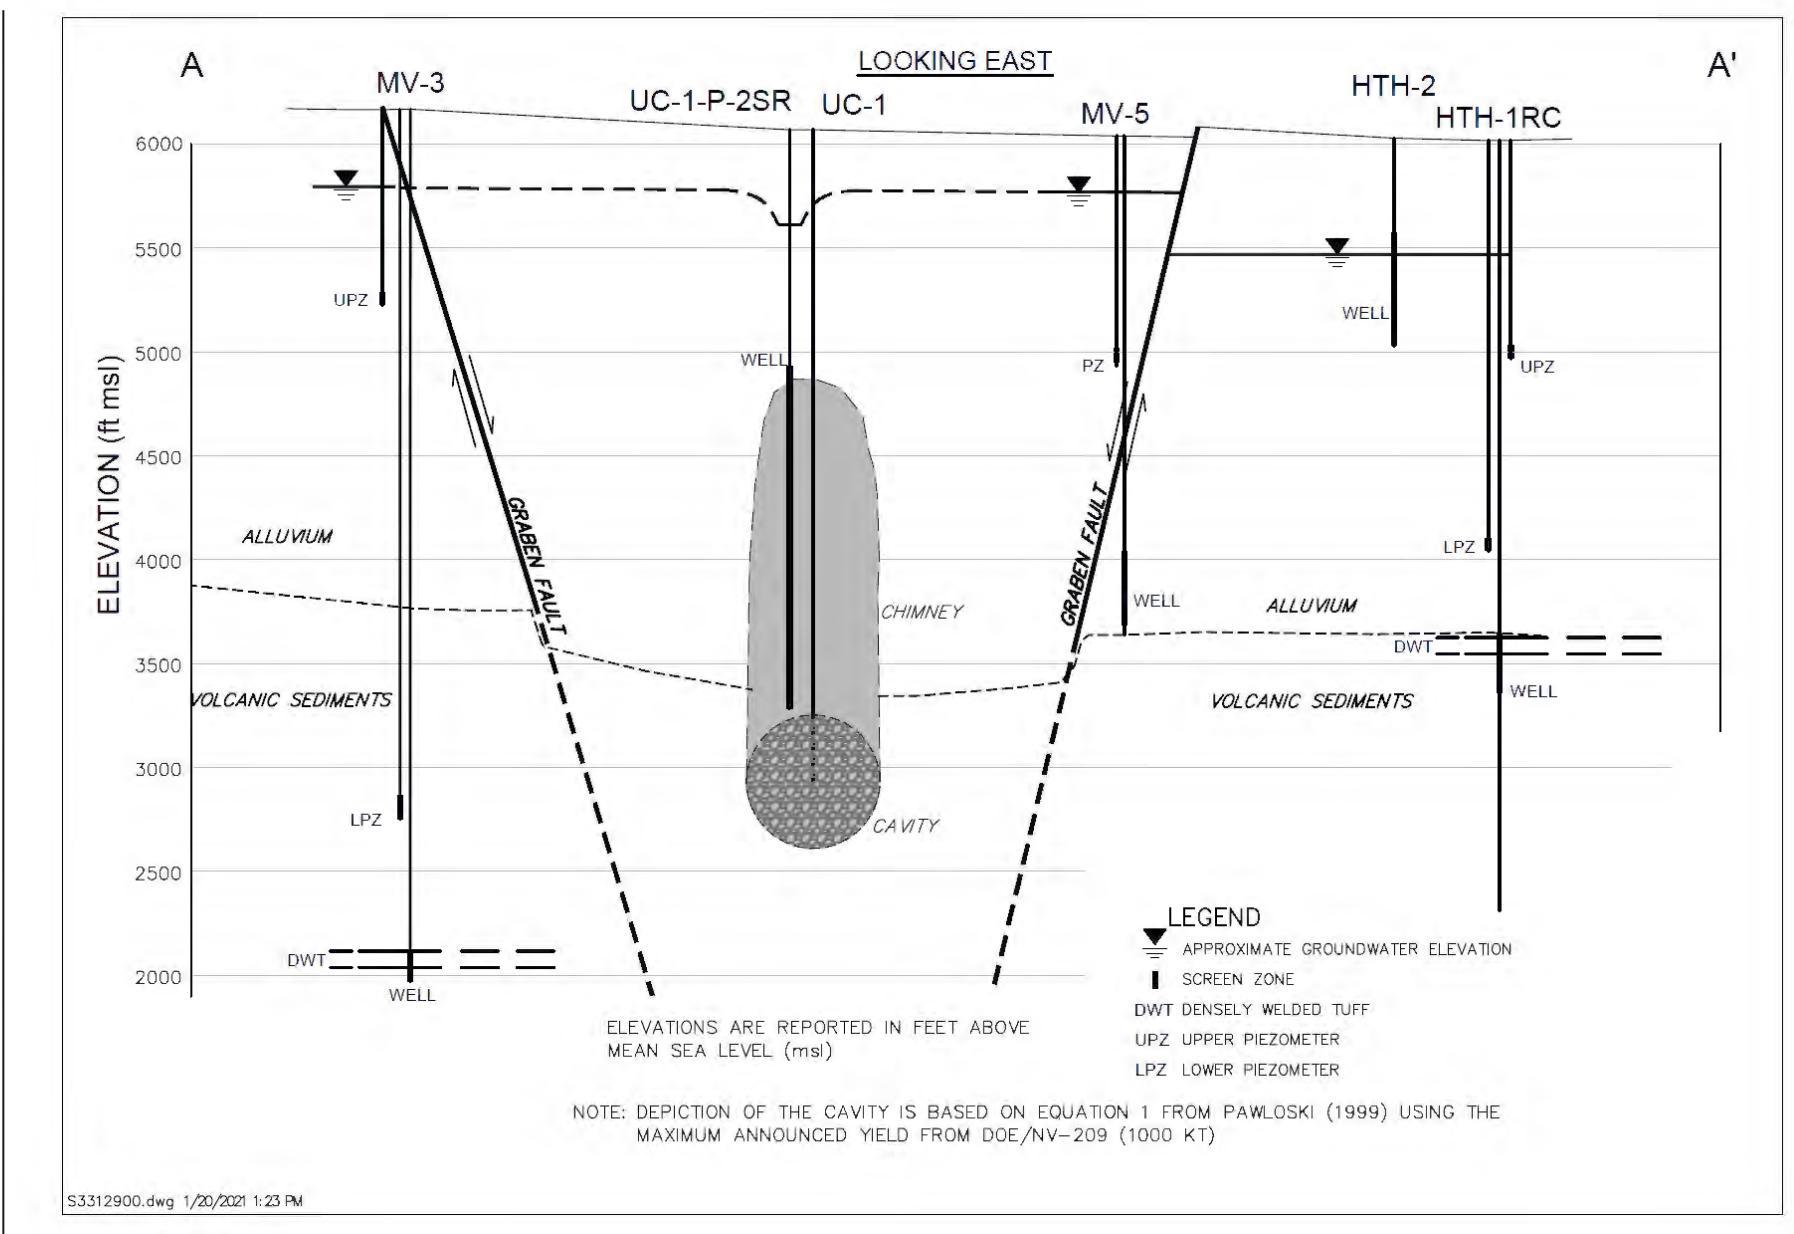
Figure 4. Cross Section View of A-A' Looking East

The underground nuclear test triggered numerous small earthquakes and aftershocks that resulted in surface subsidence and surface rupture along preexisting faults (see UC-1 site detail in Figure 2), caused strike-slip movement along previously unknown subsurface faults, and induced seismic activity as far away as 24 miles (McKeown and Dickey 1969). The test created a down-dropped fault block (also referred to as a subsidence graben) elongated to the northeast and parallel to preexisting faults in the Quaternary valley-fill deposits (Figure 3). Maximum surface displacement after the test was 14.8 ft. In some places along the south side of the graben, dip on the faults is 77 degrees to the north, based on fault intercepts in postshot boreholes and postshot map data. High-speed photography showed that subsidence occurred along the preexisting graben faults immediately following the test, indicating that subsidence resulted from the immediate release of tectonic stress that was triggered by the underground test and not from the collapse of the former cavity (McKeown et al. 1968; McKeown and Dickey 1969). Figure 4 is a cross section of the UC-1 site depicting the former cavity and chimney with faults and lithologic units.

The Faultless test took place in the low-permeability volcanic sediments (Figure 4). It was estimated that the chimney extends into the overlying alluvium to a depth of approximately 1200 ft. This estimate is based on drilling records that indicate a loss of circulation while drilling the reentry well UC-1-P-2SR at this depth. The surface location of well UC-1-P-2SR is 300 ft north of surface ground zero (SGZ) and was drilled directionally to intercept the chimney. It began to deviate from vertical at about 1500 ft (elevation of 4600 ft above mean sea level [amsl]). Well UC-1-P-2SR was drilled to a measured depth of 3554 ft (3513 ft true vertical depth) and perforated from measured depths of 1148 ft to 2792 ft (1148 ft to 2760 ft true vertical depth). The water level in the chimney is still recovering from the dewatering effects of the detonation. The water level in UC-1-P-2SR (elevation of 5647 ft amsl in mid-2021) has increased more than 1800 ft in the last 53 years at a slowing rate (Figure 5) and is expected to rise another 100 ft in the next 40 years or so (estimated based on current trend). The water level within UC-1-P-2SR should eventually reach the elevation of approximately 5750 ft amsl observed in the alluvial aquifer near SGZ.

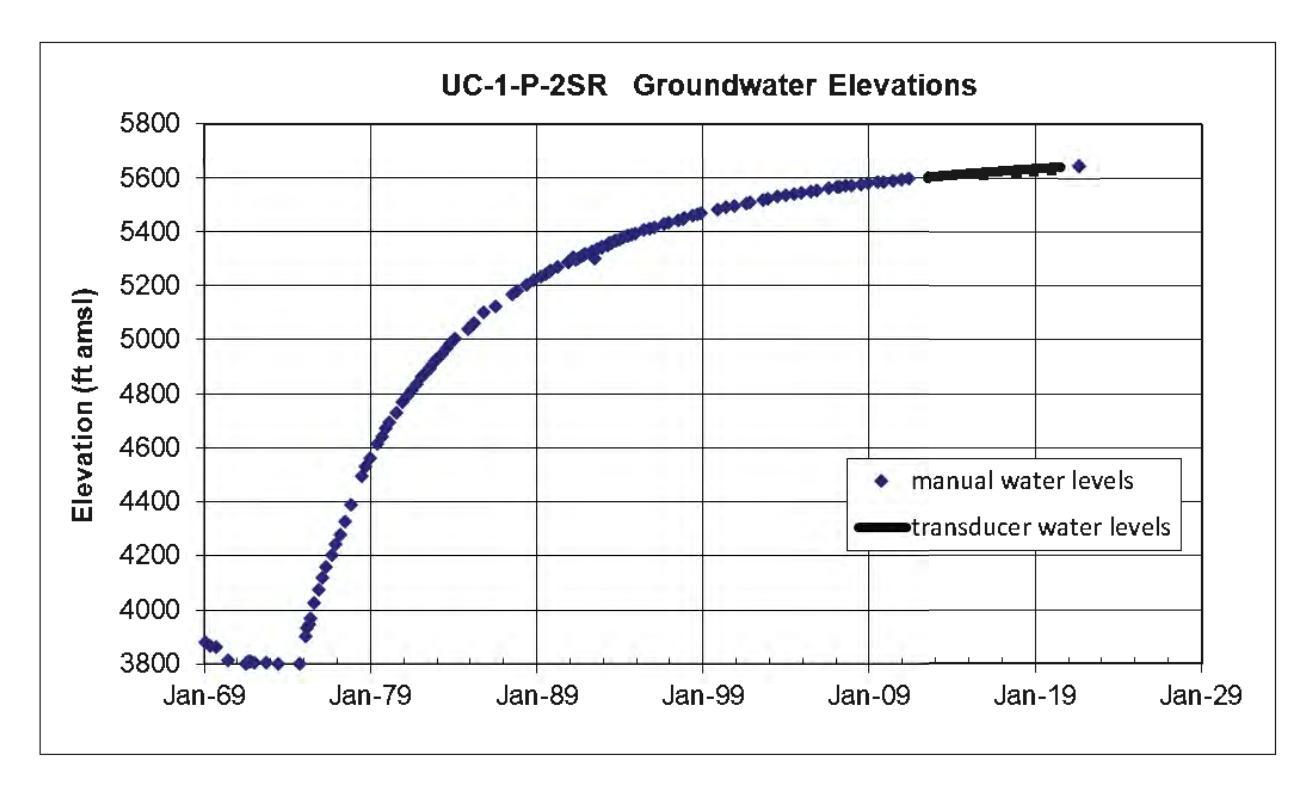
Figure 5. Water Elevations in Reentry Well UC-1-P-2SR

Water elevations in the volcanic sediments are highest at the detonation depth, likely due to a detonation-related pressure response and compaction that resulted from the graben subsidence. This is most evident inside the graben, where the water elevation is approximately 5990 ft amsl in the MV-1 lower piezometer (LPZ) that is screened at the detonation depth. The gradients obtained from the water elevations suggest that the most likely flow direction from the source zone is down, toward the densely welded tuff units (elevations of about 5565 ft amsl). Wells MV-1, MV-2, and MV-3 are screened in densely welded tuff units near and below the source zone. Water elevations from these wells and interpretations of the geometry of the major graben faults at these depths suggest a flow direction that is to the northeast in the densely welded tuff units. Aquifer tests performed on the MV-1, MV-2, and MV-3 wells indicate low hydraulic conductivity values ranging from 8.5×10^{-6} to 6.7×10^{-5} m/d (Lyles et al. 2006). The low hydraulic conductivities and anomalously long water level recovery time in UC-1-P-2SR (chimney) (Figure 5) is consistent with a detonation zone surrounded by low-permeability material.

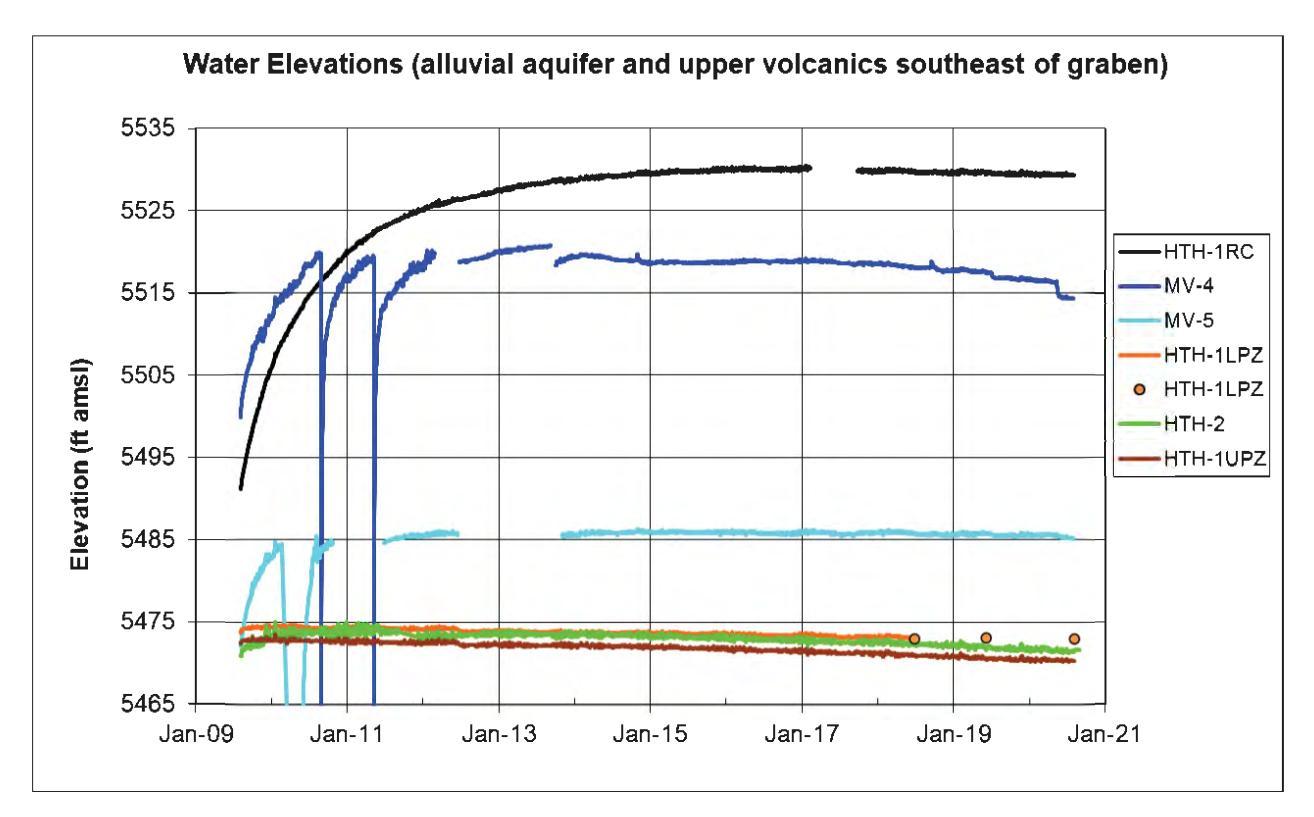
The hydrographs (Figure 6 through Figure 9) are grouped by comparable monitored interval and location: alluvial aquifer southeast of the southeast-bounding graben fault, including well HTH-1RC in the upper volcanic section (Figure 6); alluvial aquifer within the graben fault, including piezometer MV-3UPZ (Figure 7); the volcanic section with open intervals near the detonation depth (Figure 8); and the volcanic section with open intervals below the detonation depth (Figure 9). Data gaps in the hydrographs are the result of transducers being removed for well-site activities or for the replacement of damaged transducers or cable. The water elevations collected in August 2020 from wells and piezometers completed in the upper alluvial unit were used to construct a potentiometric surface of water elevations in the alluvium within the graben (Figure 10). A hydrograph of water elevations from all wells and piezometers is presented in Appendix B (Figure B-1) to allow a comparison of water elevations in each screened interval. Figure 6 shows hydrographs from January 2009 through August 2020 of wells and piezometers completed in the alluvium southeast of the graben along with well HTH-1RC (screened in the upper volcanic section below the alluvium). These data indicate that water levels in wells MV-4 and MV-5 have recovered from the 2010 aquifer testing and from the 2011 yearly sampling event during which several thousand gallons of water were removed. Low-flow bladder pumps were installed in wells MV-4 and MV-5 during the November 2013 sampling event to reduce the well purge volumes and the impact purging has on the water levels during sampling (DOE 2014). Water levels in well HTH-1RC have recovered from the recompletion in 2009. Before its recompletion, well HTH-1 had been perforated across its entire saturated section, and its water level was a composite of several hydrostratigraphic units. The recompletion isolated zones in the upper and lower alluvium (HTH-1UPZ and HTH-1LPZ) and in the volcanic section (HTH-1RC). HTH-1RC isolated a densely welded tuff unit above the detonation depth, but the original well casing remains open below an obstruction at 2812 ft (elevation of about 3200 ft amsl) to the original depth of 3704 ft (elevation of about 2300 ft amsl), allowing contribution from the volcanic section below the detonation zone (Figure 4). The water elevation in the volcanic section (HTH-1RC) is higher than water elevations in both the upper and lower alluvial piezometers (HTH-1UPZ and HTH-1LPZ). This observation confirms that an upward gradient from the volcanic section to the alluvium exists in this interval south of the graben, as had been indicated by flow logging performed by Desert Research Institute (DRI) before the well's recompletion (DOE 2008). The transducer in the piezometer HTH-1LPZ was replaced during the August 2020 field event because it was not functioning correctly.

Figure 6. Water Elevations for the Alluvial Wells and Well HTH-1RC (Upper Volcanics) Southeast of the Down-Dropped Graben at the Screened Horizon

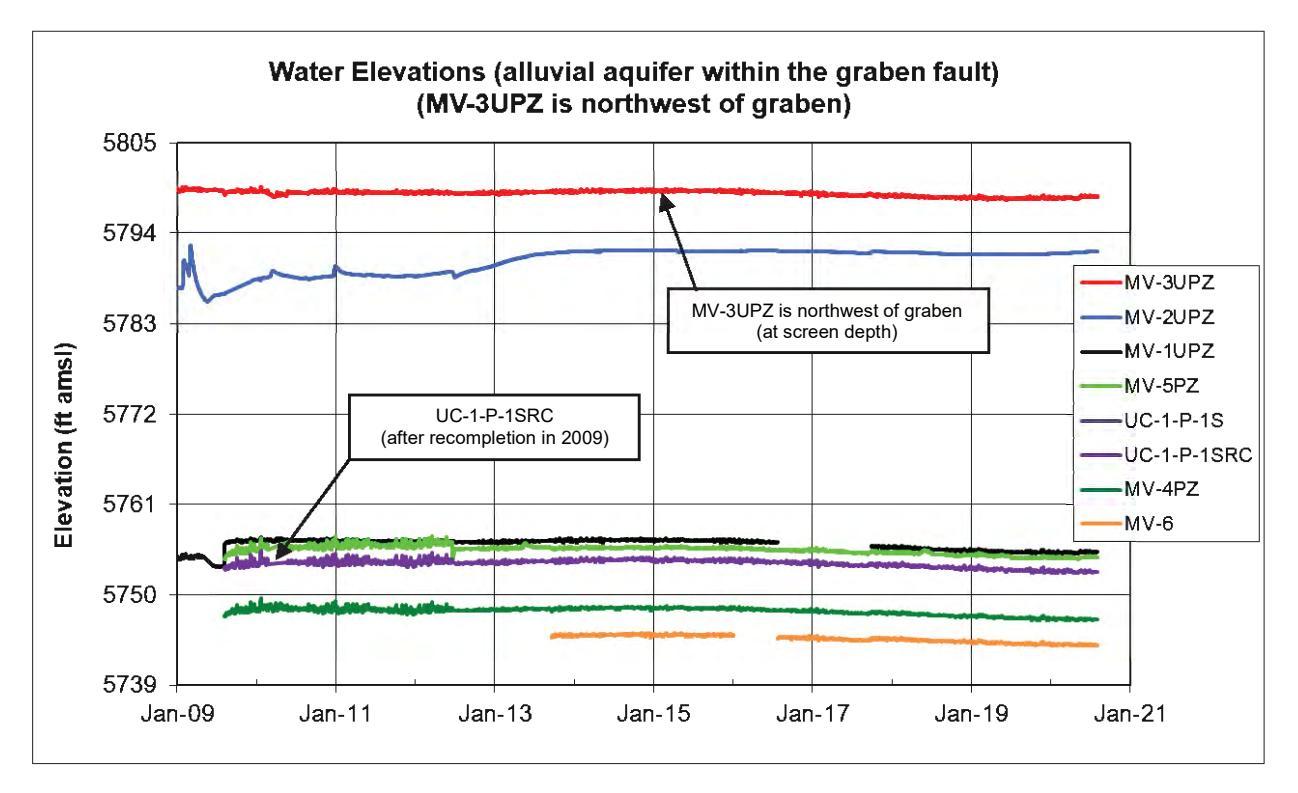
Figure 7 shows hydrographs from January 2009 through August 2020 of piezometers and wells completed in the alluvium within the graben and northwest of the graben. The water elevations in the piezometers MV-4PZ and MV-5PZ (screened inside the graben) are approximately 250 ft higher than those in wells MV-4 and MV-5 that are screened outside the graben to the southeast (Figure 6). These results support that the southeast-bounding graben fault acts as a barrier to flow. The alluvial aquifer hydrographs were separated into two groups based on their screened location relative to the southeast-bounding graben fault.

Figure 7. Water Elevations for the Alluvial Wells Northwest of the Southeast-Bounding Graben Fault

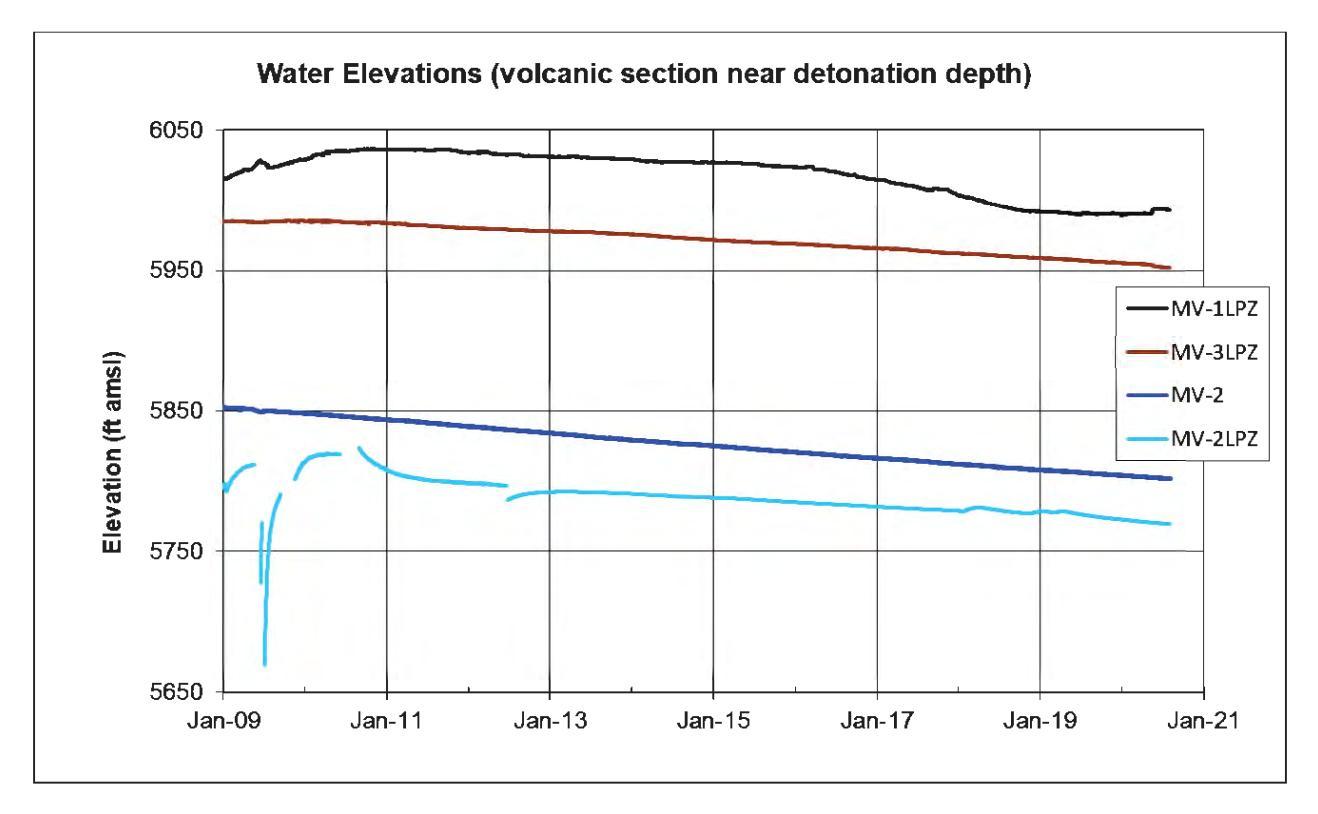
Figure 8 shows hydrographs from January 2009 through August 2020 of the piezometers and well with open intervals in the volcanic section near the detonation depth. Water elevations in these wells and piezometers have been declining since their installation in 2005; the exception is MV-1LPZ, which had a rising water elevation until 2011, then began to decline through 2018, and has now appeared to stabilize. Water elevations in MV-2LPZ have been decreasing since 2010 at about the same rate (about 5 ft per year) as the other wells and piezometers screened in the volcanic section. The declining water elevations (highest observed in the volcanic section) are attributed to a slow release of the detonation-related pressure response that persists due to the low permeability of the volcanic section. The highly variable water levels in the MV-2LPZ (Figure 8) are attributed to the proximity of the MV-2LPZ screened interval to the northwest-bounding graben fault. It is interpreted that water levels southeast of this fault (within the graben) are higher than water levels to the northwest, outside the graben at this depth. The abrupt water level decrease (MV-2LPZ) in mid-2009 followed by a recovery is attributed to a temporary leakage of more water or pressure to the lower fault block to the northwest. Water elevations in the MV-2LPZ are believed to have contributions from inside (southeast) and outside (northwest) the graben. The MV-2 well had to be screened above the MV-2LPZ because of drilling difficulties that are believed to be related to encountering the graben fault. Water

levels in the MV-2 well (screened inside the graben) are higher than those in the MV-2LPZ and have also been steadily decreasing (Figure 8). The abrupt change in water levels in the MV-2LPZ do not have to be associated with significant water or pressure movement. The June 2010 spike up in water levels and the June 2012 spike down (both obvious with daily data) are attributable to the installation (2010) and subsequent removal (2012) of a direct-read transducer with a quarter-inch cable 200 ft below water. The slow recovery of water levels in the MV-2LPZ in response to what should be minor perturbations attests to the low permeability of the section.

Figure 8. Water Elevations for the Well and Piezometers Screened in the Volcanic Section at or near the Depth of the Detonation

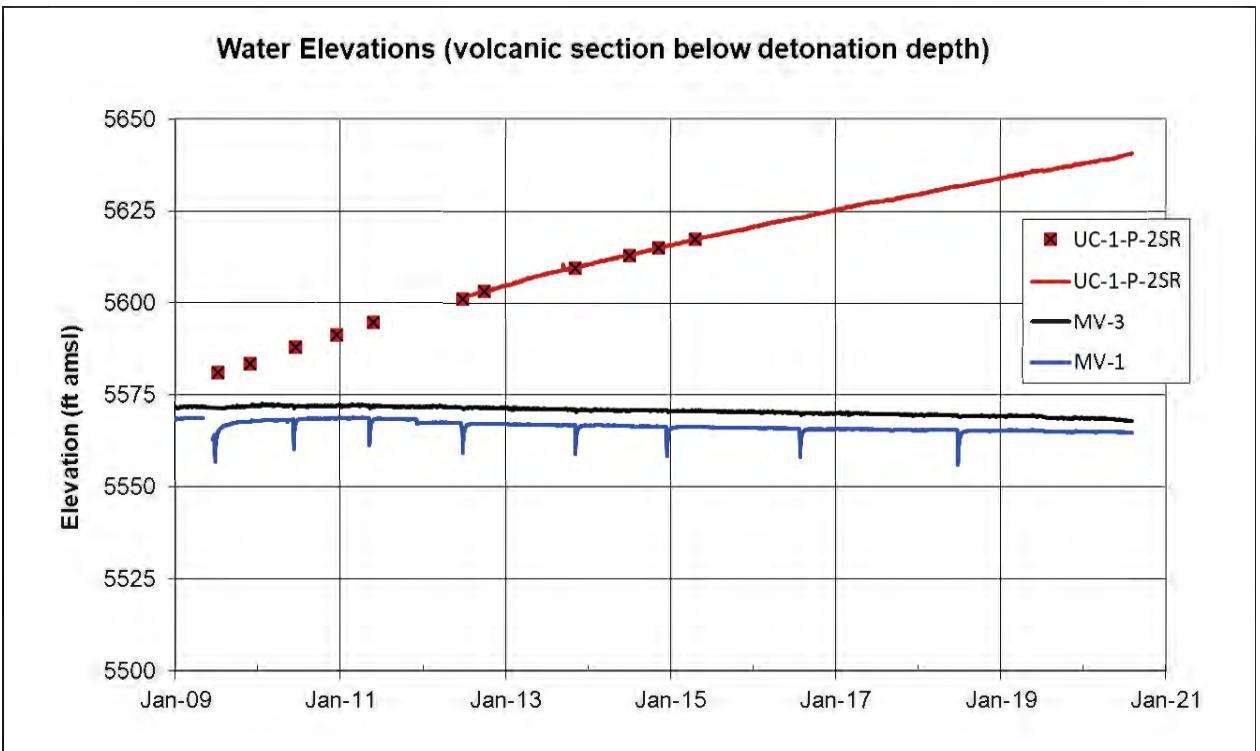
Figure 9 shows hydrographs from January 2009 through August 2020 of wells with open intervals below the detonation depth and reentry well UC-1-P-2SR. The composite water level from UC-1-P-2SR (chimney and alluvium overlying the former cavity) is higher than in the densely welded tuff units below the detonation zone. The composite water elevation of 5647 ft amsl measured in August 2021 (Table 4) continues to increase, though at a rate that is decreasing. Well UC-1-P-2SR has perforations as high as 1148 ft in the alluvium, and its water level is expected to eventually reach a steady-state elevation of approximately 5750 ft amsl (similar to other alluvial wells and piezometers within the graben). Well UC-1-P-2SR was evaluated during the August 2021 sampling event to assess flow within the well. This evaluation was conducted by DRI using their chem tool to log groundwater temperatures, pH, and specific conductance within the UC-1-P-2SR water column. It was determined during this evaluation that groundwater enters the well between the depths of 1420 and 1805 ft (elevations 4664 to 4279 ft amsl). The water entering the well moves upward and downward within the well. The water moving upward within the well exits the well between the depths of 1165 and 1270 ft

(elevations 4919 to 4814 ft amsl) and the water moving downward exits the well between the depths of 1975 and 2060 ft (elevations 4109 and 4024 ft amsl). This groundwater movement within the well is consistent with data and interpretations obtained by DRI in 1997 and 2012 (DOE 2013). A copy of the DRI evaluation is provided as Appendix D.

Note: Water elevations for reentry well UC-1-P-2SR (drilled into the chimney) are shown for reference.

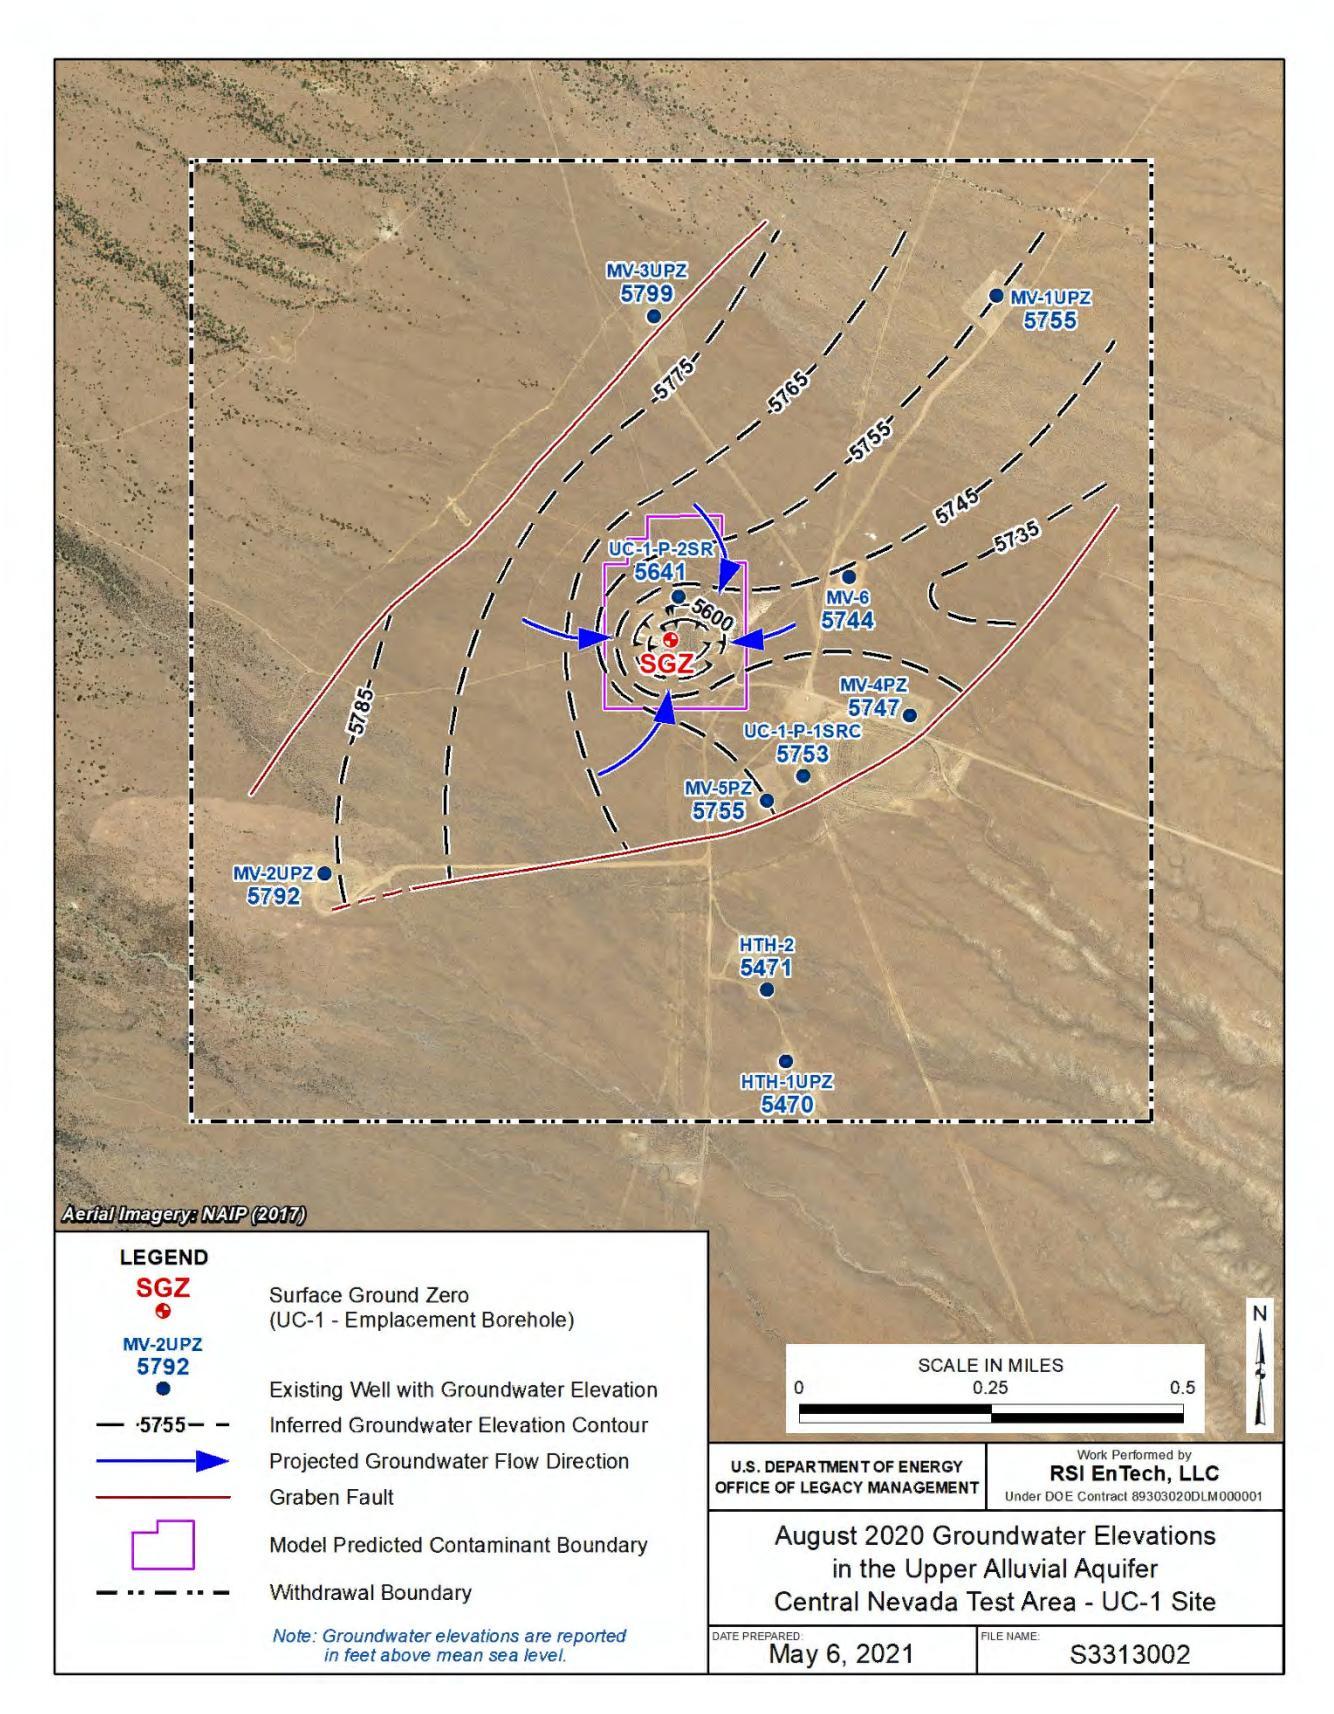
A potentiometric map of the upper part of the alluvial aquifer within the graben (Figure 10) was constructed using August 2020 water levels from MV-4PZ, MV-5PZ, MV-6, UC-1-P-1SRC, MV-1UPZ, and MV-2UPZ. These locations are screened at depths ranging from 600 to 1000 ft. Given that the faults act as barriers to flow, there are not enough data points to extend the map beyond the graben (MV-3UPZ is northwest of the graben, while HTH-2 and HTH-1UPZ are southeast of the graben). Groundwater elevations for the locations outside the graben are provided on Figure 10 for comparison with upper alluvial groundwater elevations within the graben. Contours near SGZ are based on the composite water level from well UC-1-P-2SR. The interpretation seen in Figure 10 suggests that horizontal flow in the upper alluvium is toward the chimney near SGZ. Away from the chimney's influence, horizontal flow is east-southeast and likely deflected by the southeast-bounding graben fault that is acting as a barrier to flow. As drawn, the contours indicate that groundwater flow near well MV-6 is toward the west. This is influenced by the lower groundwater elevation in well UC-1-P-2SR, which is still recovering from the detonation. Depiction of groundwater flow directions within the graben has an inherent degree of uncertainty, given the structural complexity caused by the detonation and the limited data available within the graben near the detonation.

Figure 10. August 2020 Groundwater Elevations in the Upper Alluvial Aquifer CNTA–UC-1 Site

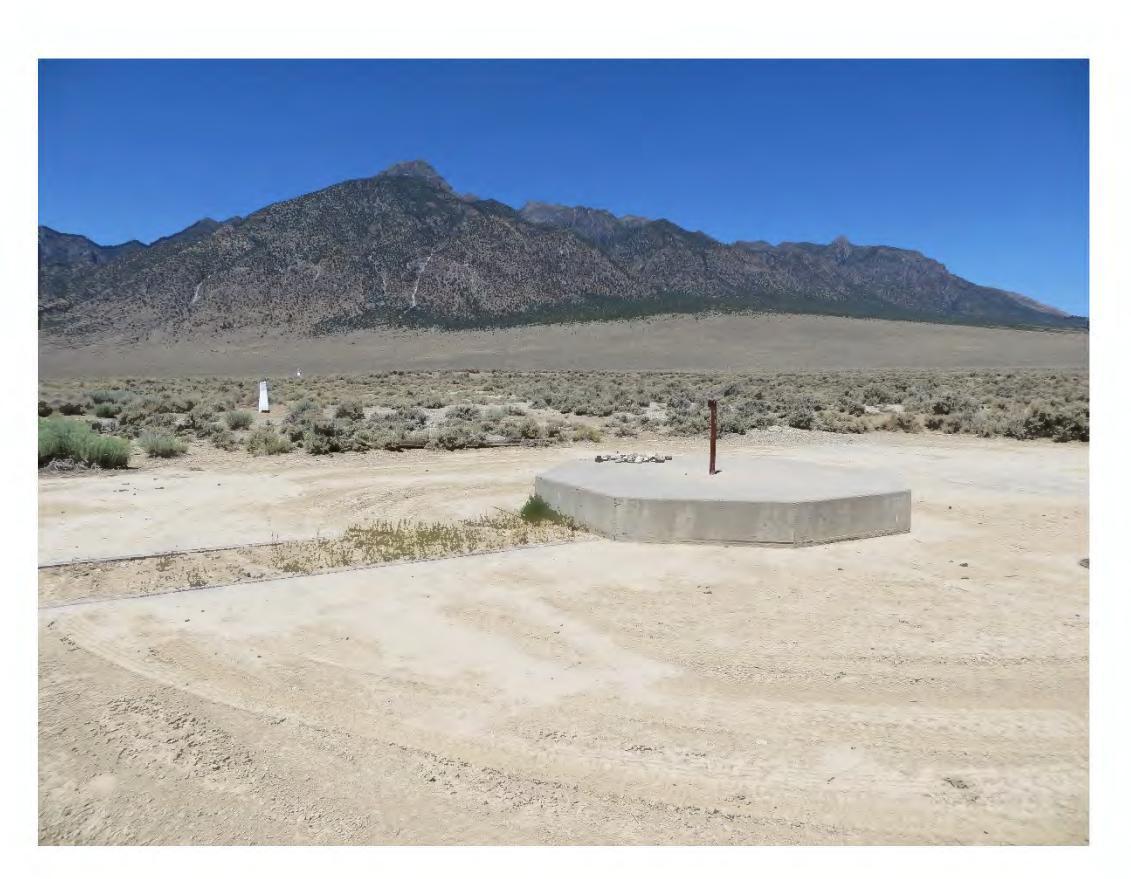
Figure A-1. Concrete Cap That Covers the UC-3 Borehole (August 2020)

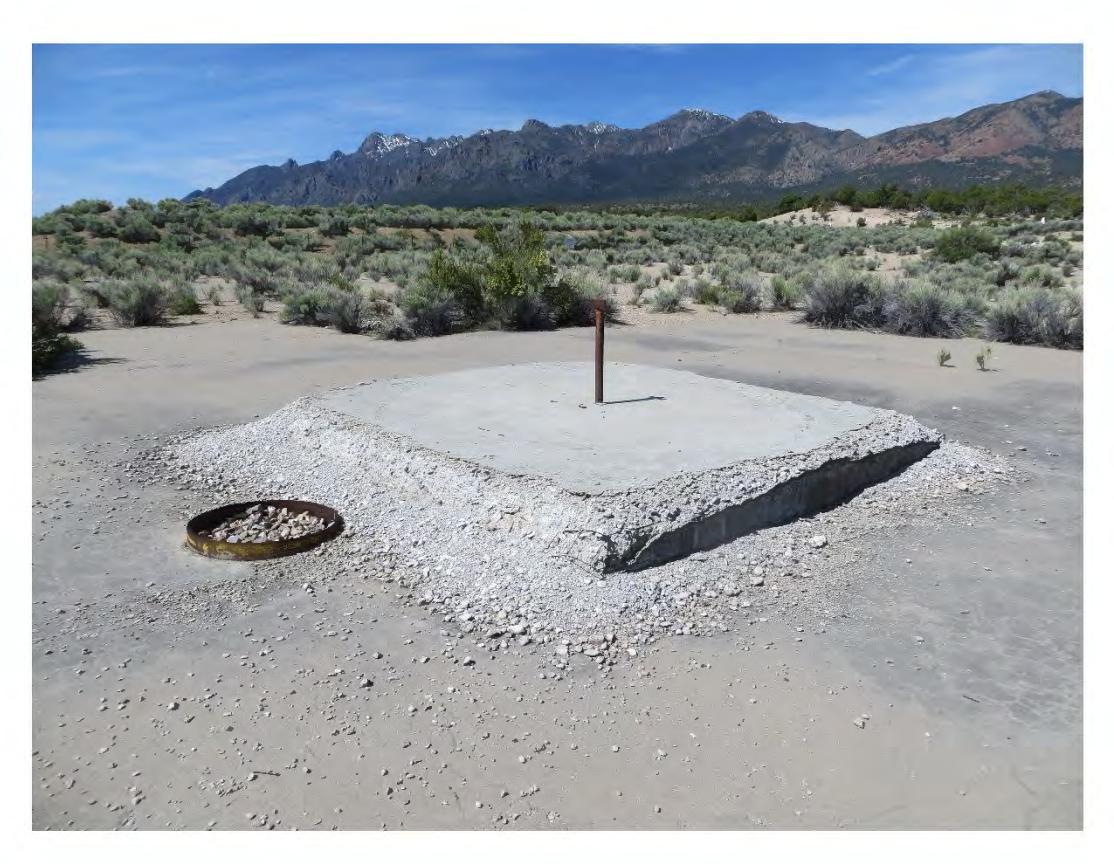
Figure A-2. Concrete Cap That Covers the UC-4 Borehole (June 2019)

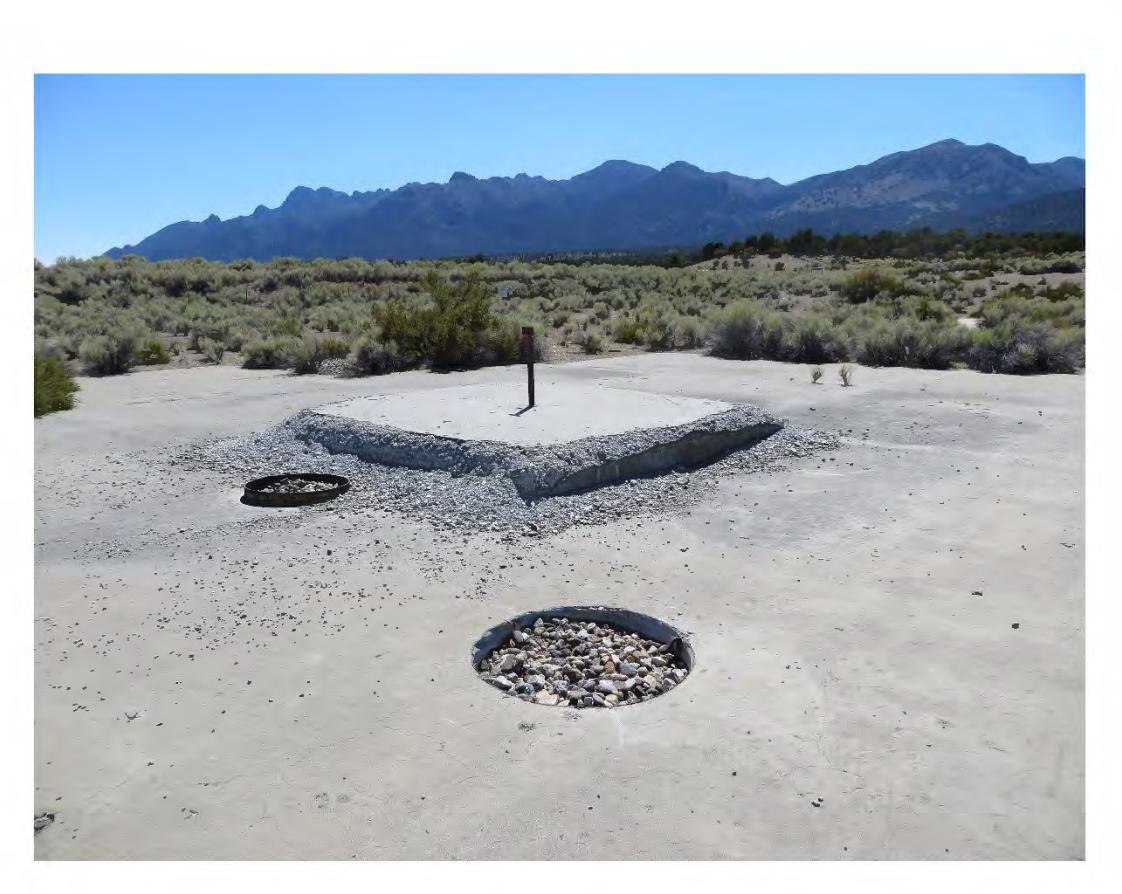
Figure A-3. Concrete Cap That Covers the UC-4 Borehole (August 2020)

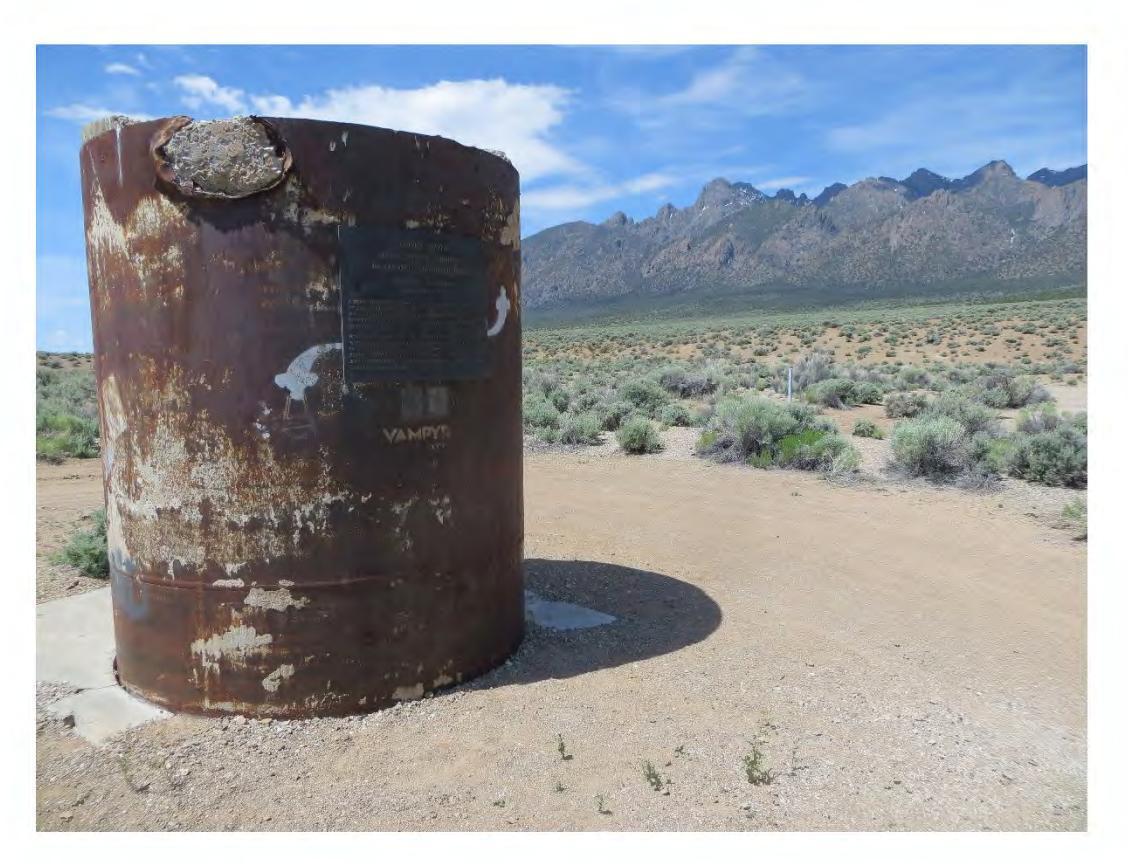
Figure A-4. UC-1 Monument Plaque on the Emplacement Borehole Casing (June 2019)

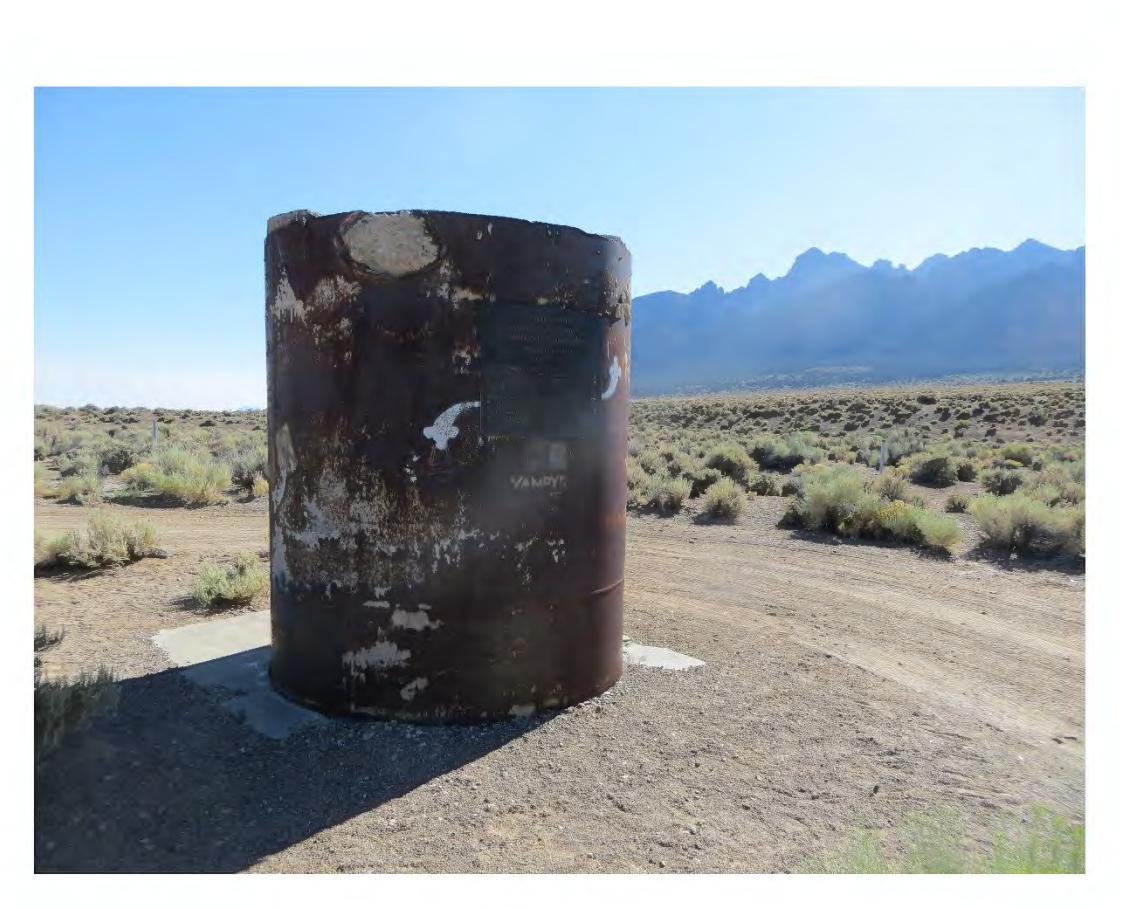
Figure A-5. UC-1 Monument Plaque on the Emplacement Borehole Casing (August 2020)

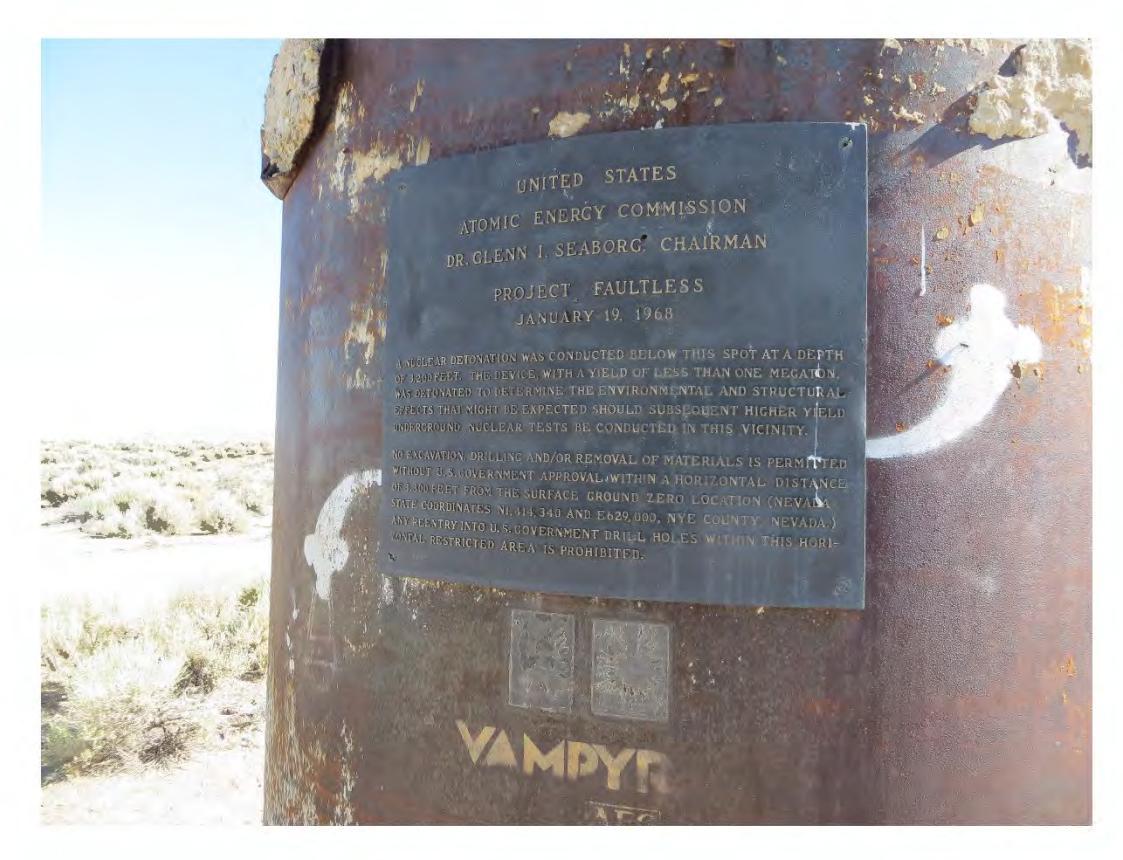
Figure A-6. UC-1 Monument Plaque on the Emplacement Borehole Casing (August 2020)

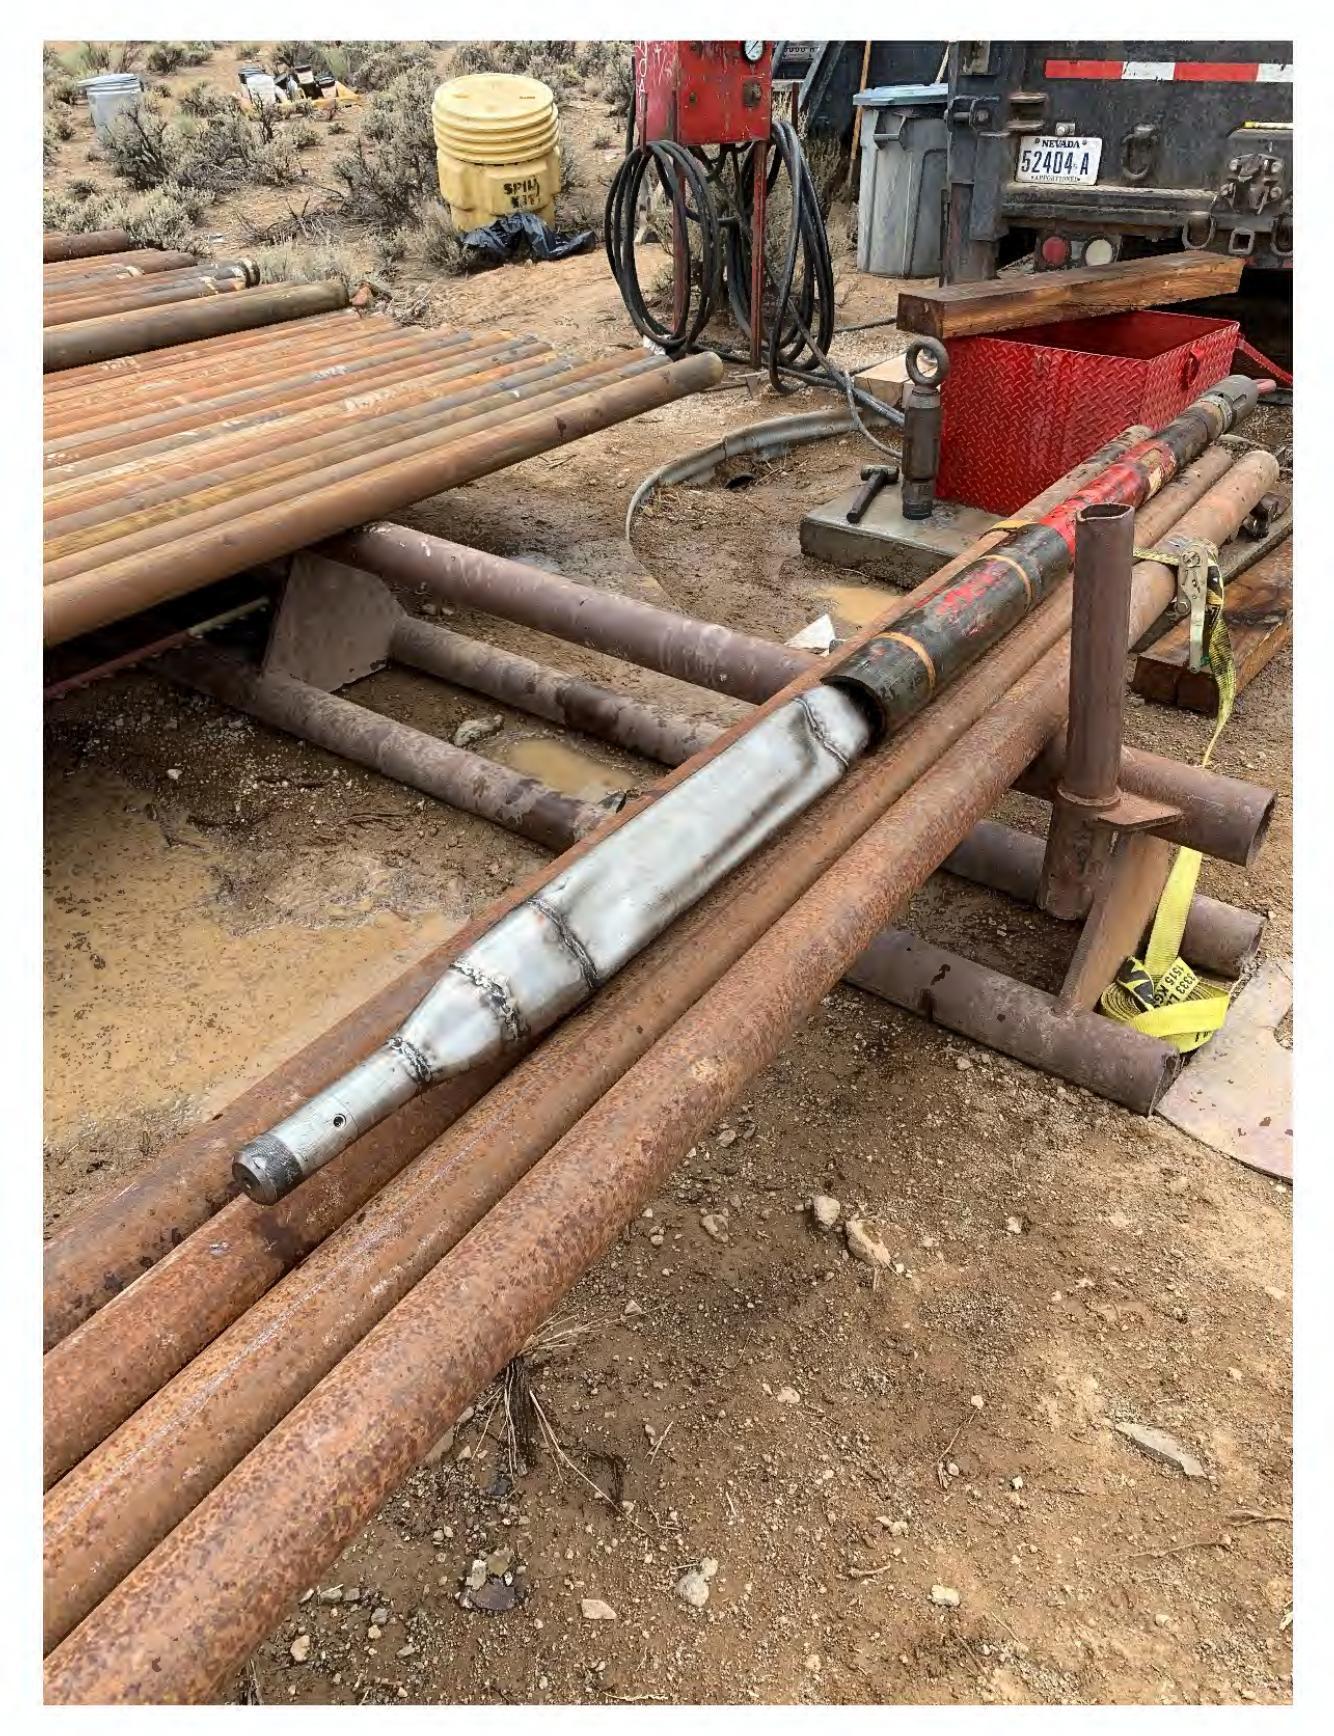
Figure A-7. Bailer Recovered from Well UC-1-P-2SR (July 2021)
