'''||| **2020 Postclosure Groundwater Monitoring and Inspection Report, Central Nevada Test** Area, Subsurface Corrective **Action Unit 443** February 2023 Approved for public release; further dissemination unlimited U.S. DEPARTMENT OF ENERGY | Legacy Management

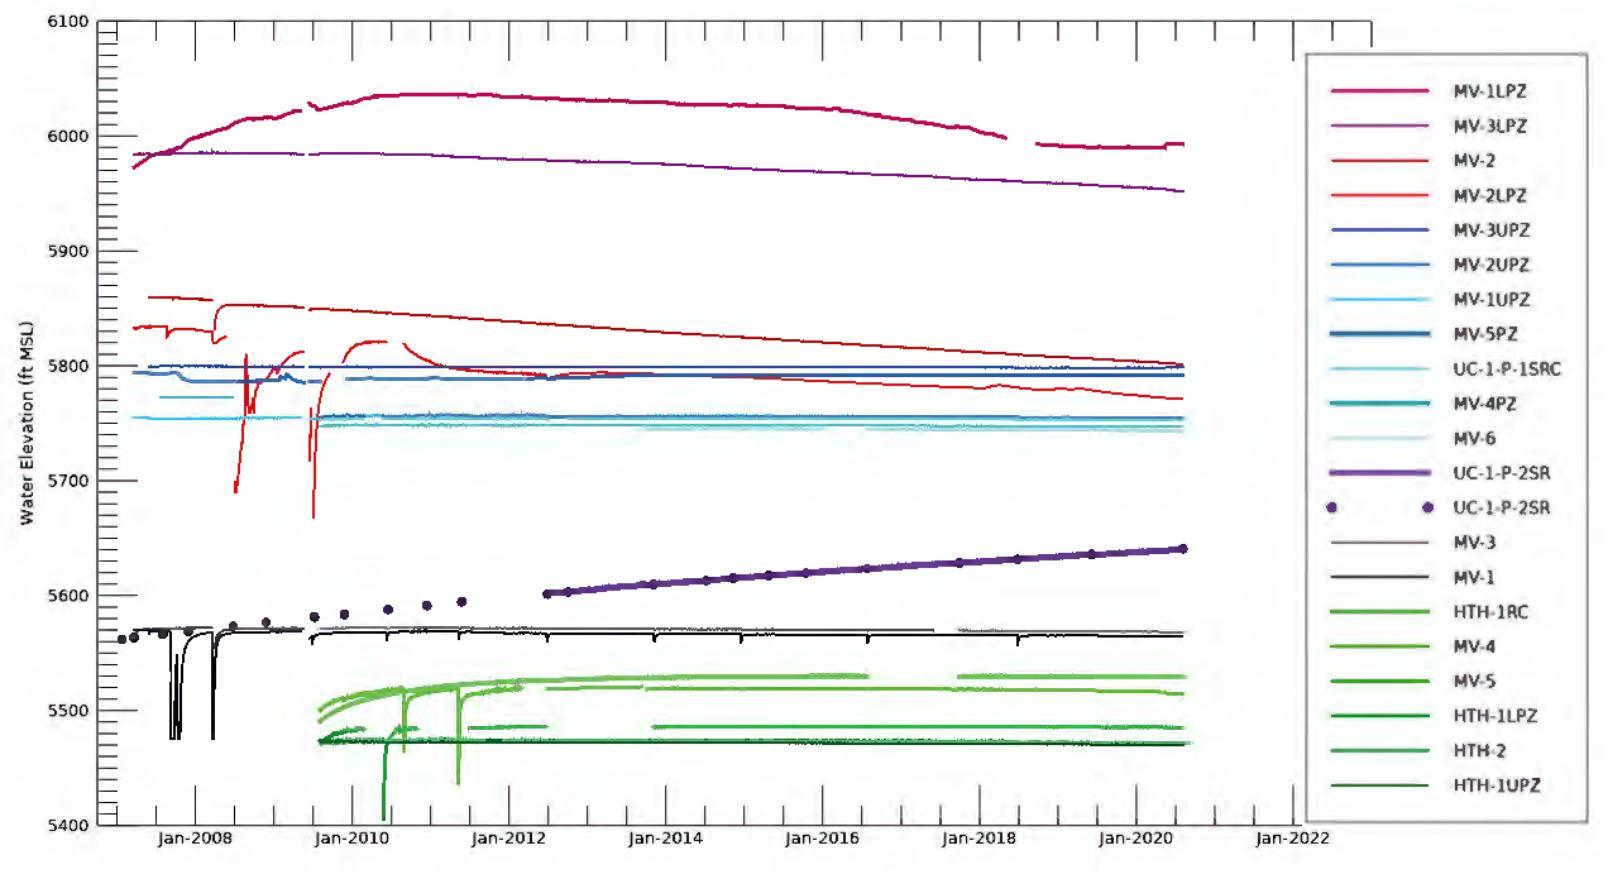
Figure B-1. Water Level Elevations for All Wells and Piezometers

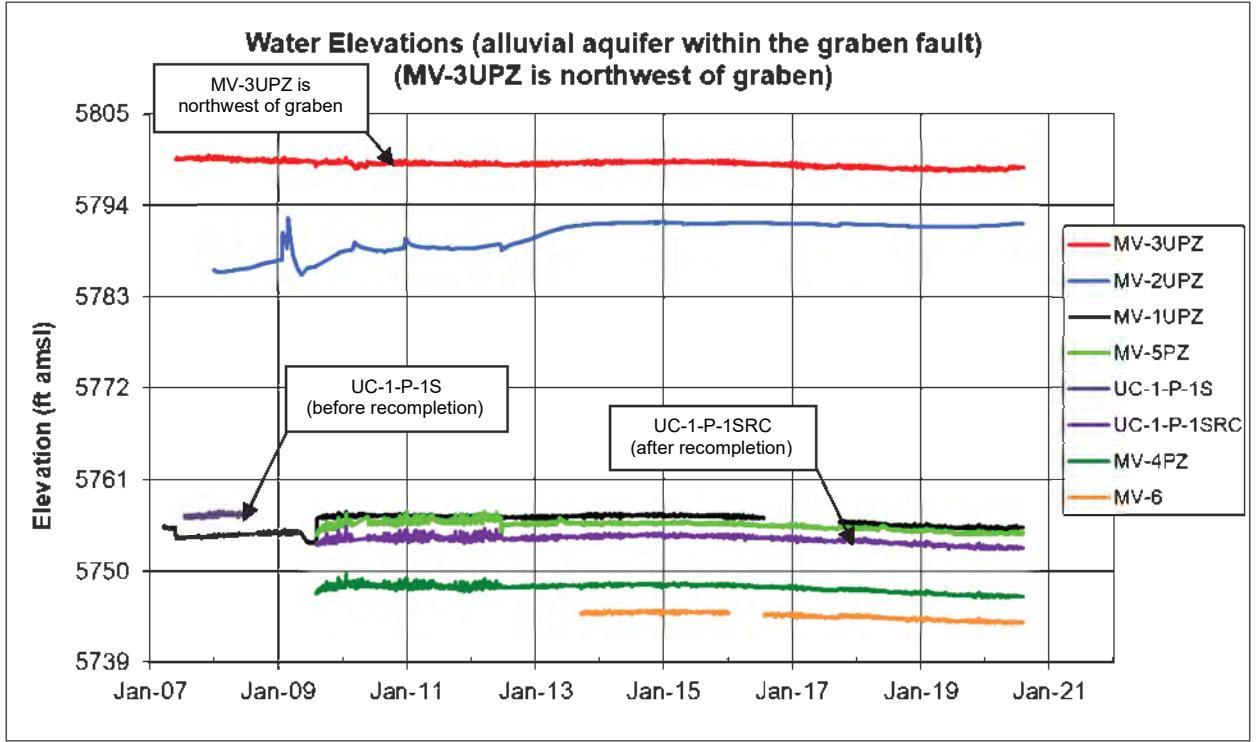
Note: Water depths collected using transducers appear as lines.

Figure B-3. Water Level Elevations for Alluvial Wells Northwest of the Southeast-Bounding Graben Fault

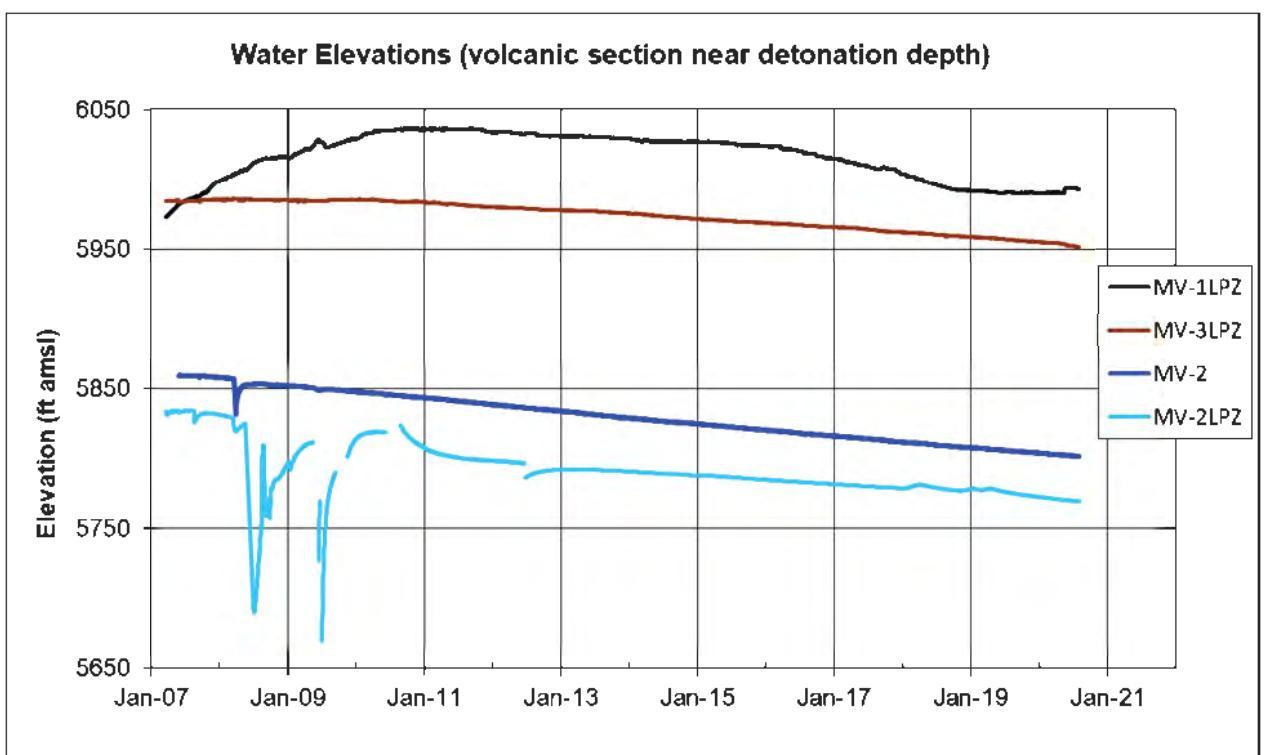
Note: Water depths collected using transducers appear as lines.

Figure B-4. Water Level Elevations for the Well and Piezometers Screened in the Volcanic Section at or near the Level of the Detonation

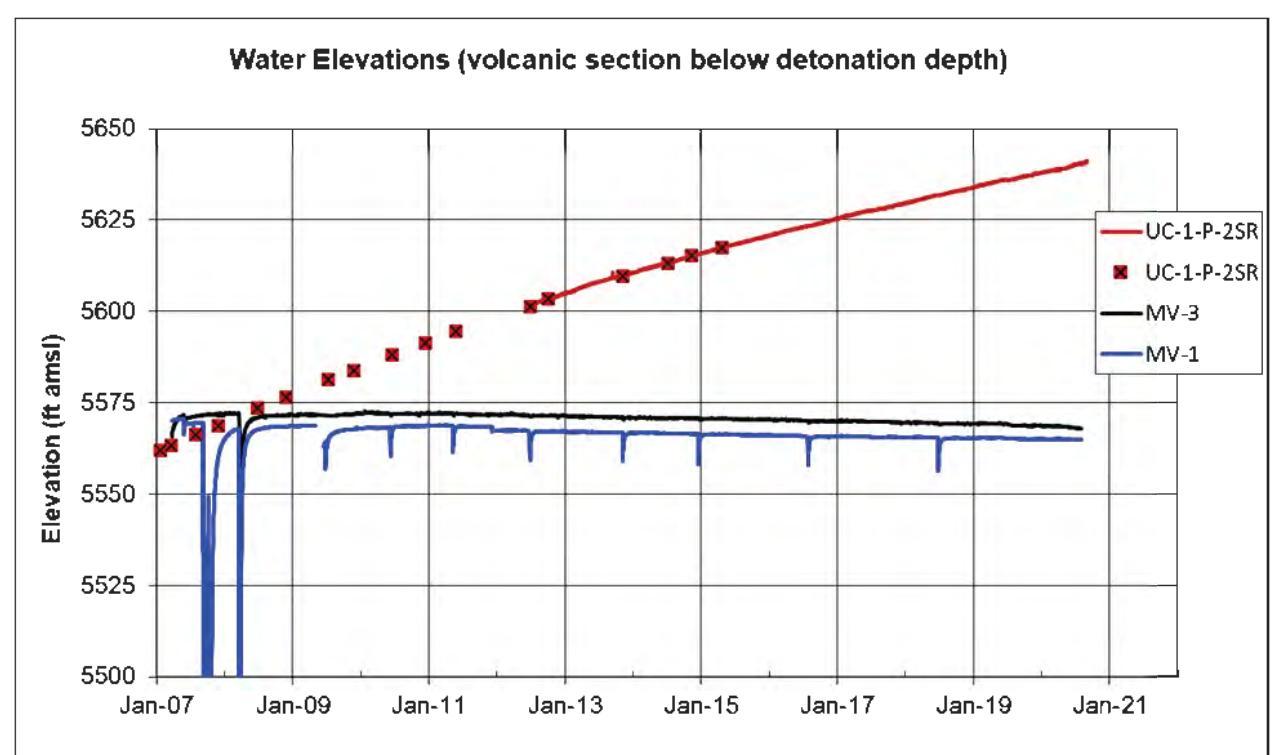
Note: Water depths collected using a water level tool appear as individual symbols, and water depths collected with transducers appear as lines.

Figure B-5. Water Level Elevations for Wells Screened in the Volcanic Section Below the Level of the Detonation

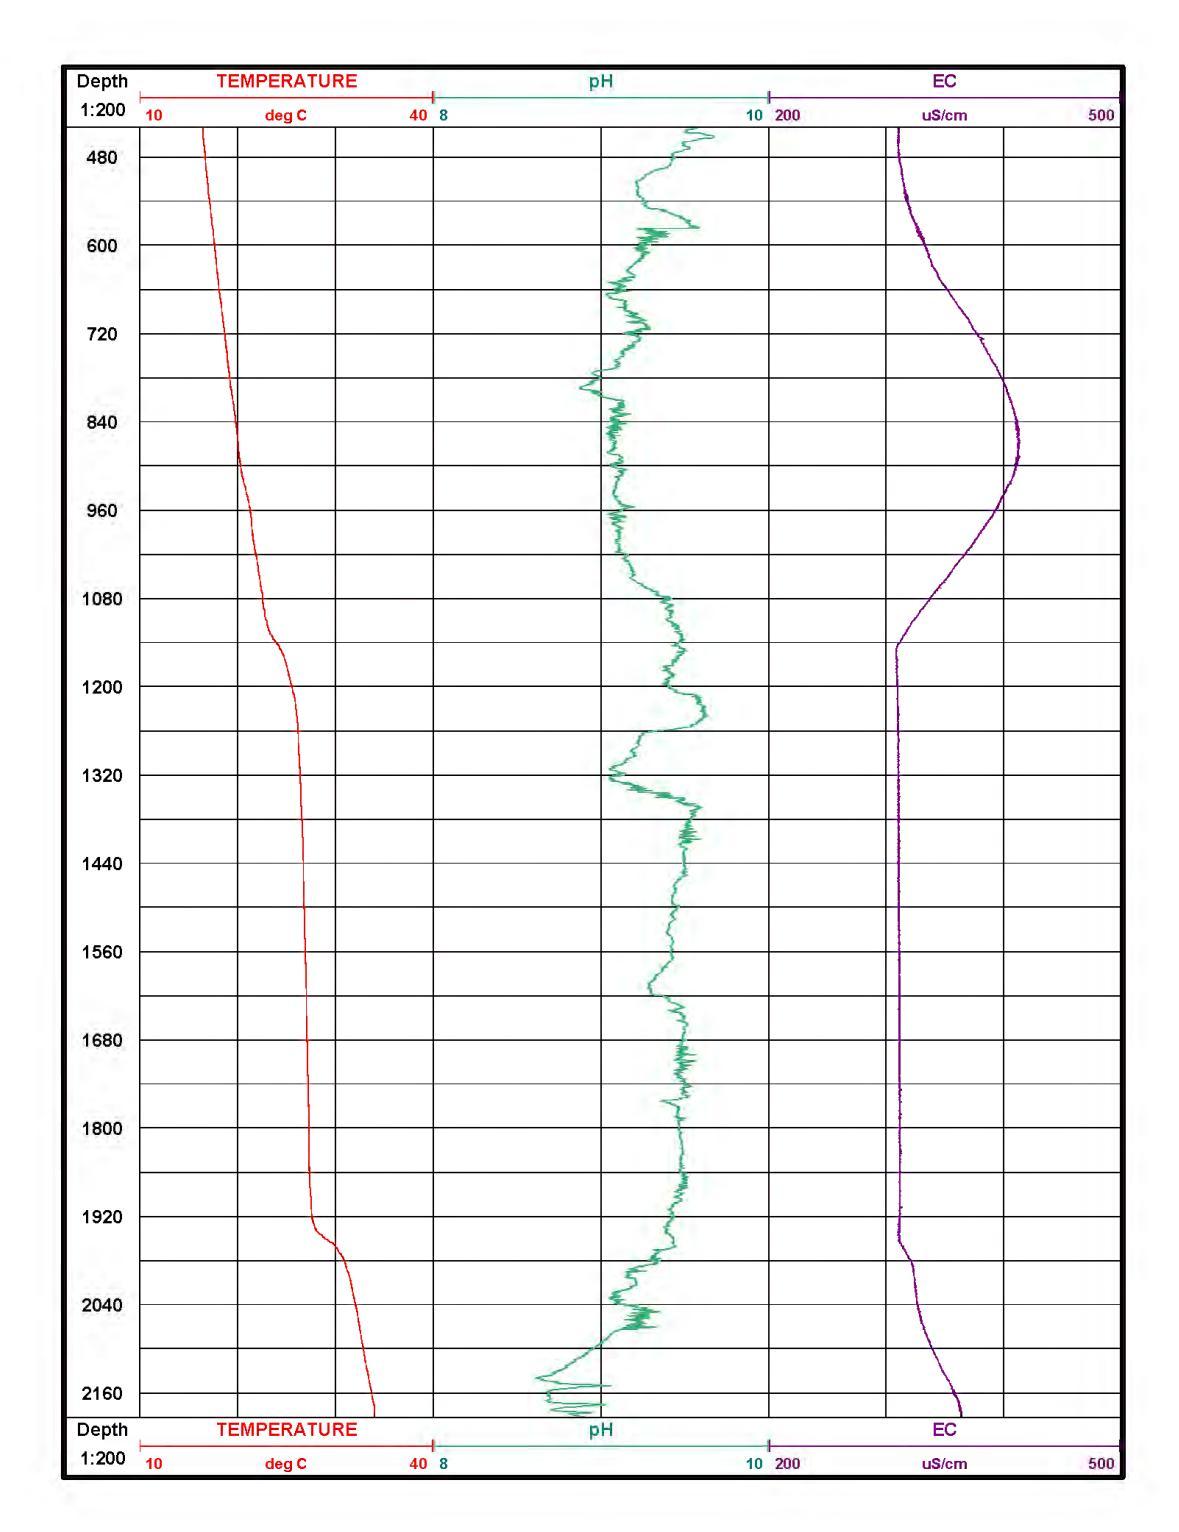
Chemistry logging results for the upward log of well UC-1-P-2SR are shown in Figure 1. The downward log was run at a higher-than-normal rate, and sensors did not fully equilibrate to borehole conditions. The temperature log shows changes from the geothermal gradient at two depth zones, 1165 ft bls and 1975 ft bls, as illustrated in Figure 2. The thermal gradient was computed at each log measurement point by subtracting the temperature 50 ft below the measurement point from the temperature 50 ft above the measurement point, then dividing by 100 ft (the measurement depth difference); therefore, the thermal gradient could not be computed for the top 50 ft or bottom 50 ft of the log. The temperature was nearly constant from 1460 to 1810 ft bls. The electrical conductivity was virtually uniform between 1120 to 1940 ft bls, indicating active vertical flow. Likewise, pH was relatively unchanged in the zone from 1120 to 1940 ft bls. Figure 2 shows that water is leaving the well in two zones: the upper zone between 1165 and 1270 ft bls and the lower zone between 1975 to 2060 ft bls. The inflow zone is harder to identify from the temperature log but is most likely between 1420 and 1805 ft bls. The water entering the well in the inflow zone moves both upward and downward in the well. The upward moving water exits the well in the upper outflow zone between 1165 and 1270 ft bls, and the downward moving water exits in the lower outflow zone between 1975 and 2060 ft bls. This is the same pattern that was observed in 1997 and 2012 when the thermal flow meter (also called TFM) logging tool was run in the well.

Figure 1. Well UC-1-P-2SR chemistry well logging results of the upward log, August 19, 2021.

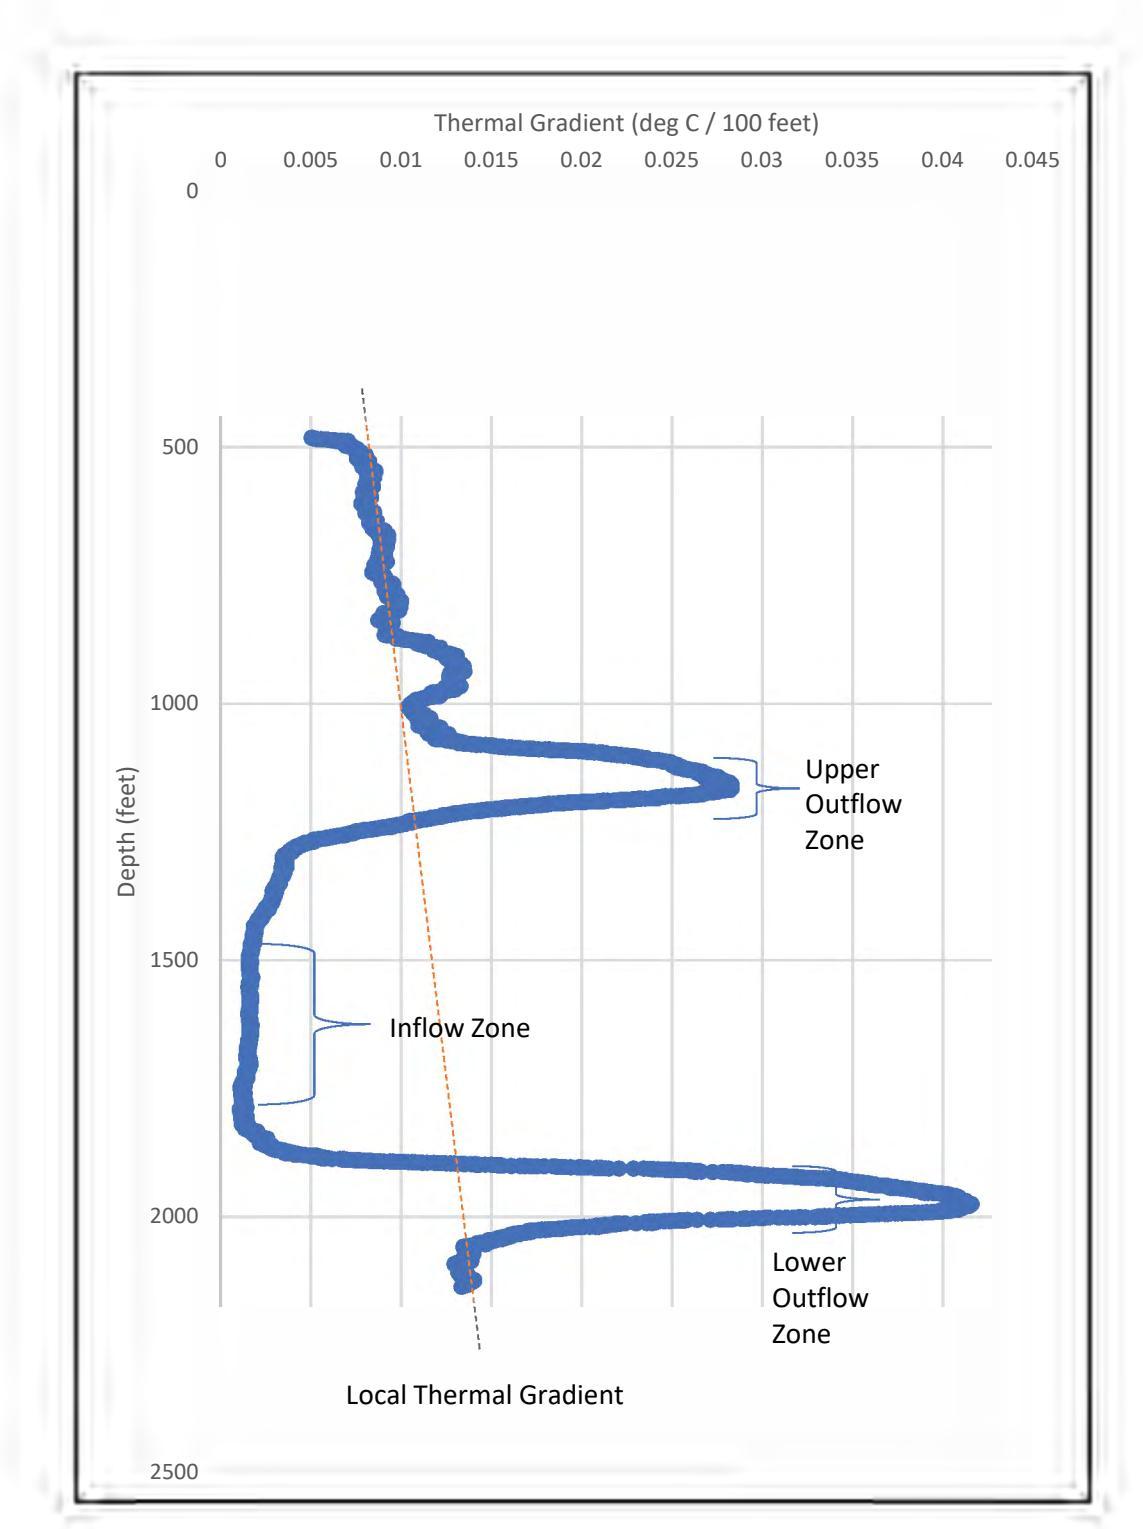
Figure 2. Well UC-1-P-2SR thermal gradient from upward temperature log results. (Brackets indicate potential inflow and outflow zones, and the red dashed line shows the local thermal gradient.)

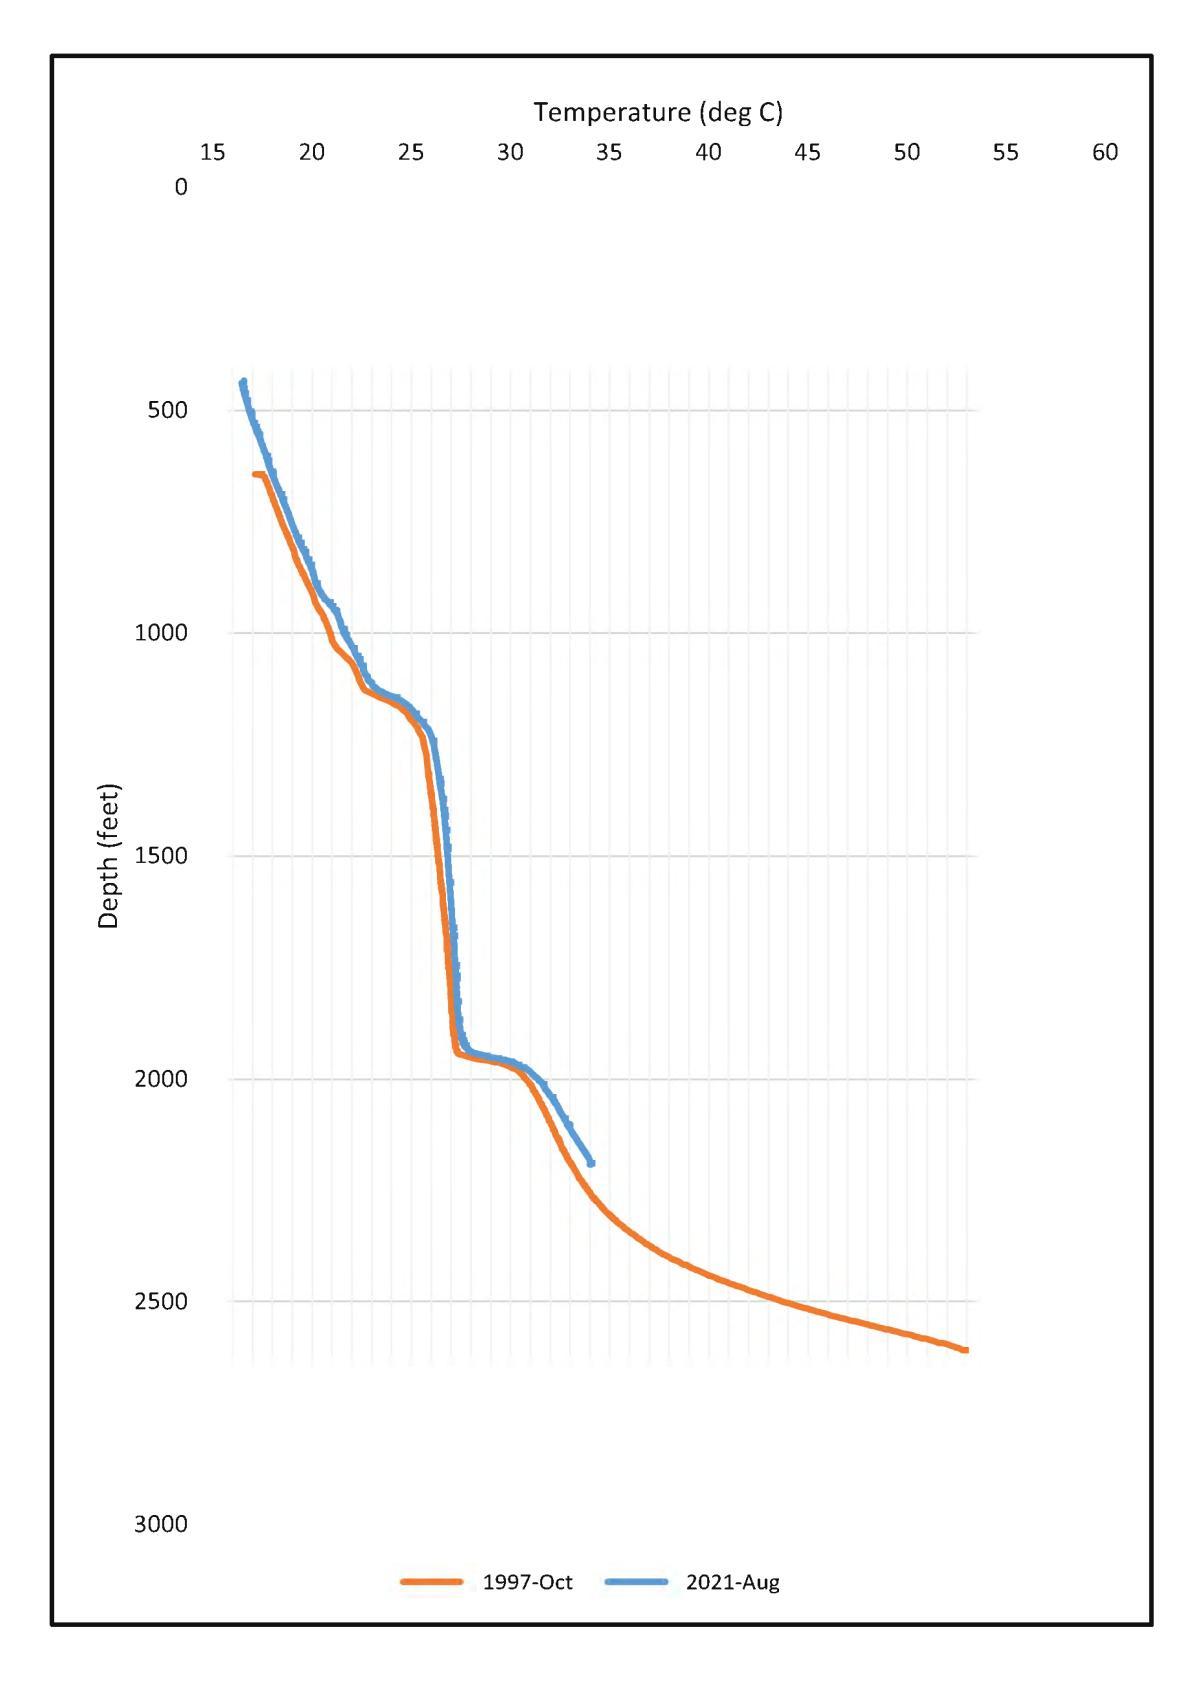
Temperature logs have been performed by DRI in well UC-1-P-2SR seven times from 1992 to 2021. The log results are similar, as shown in Figure 3, except for the log from 2012. Past field activities and data collection/analysis for UC-1-P-2SR are summarized in Lyles and Chapman (2012). The 2012 log was performed with a backup tool when the primary tool failed. Although the trend from this log is similar to other logs, it stands out as having electronic noise and, potentially, a bad calibration. No temperature logs have been performed to the total depth (2615 ft bls) of the well since 1997; therefore, it is not possible to determine if the bottom hole temperature is cooling as expected. However, a comparison of the temperature logs in 1997 and 2021 shows the temperature at 2190 ft bls has increased about 1 °C since 1997. The remainder of the 2021 log is about 0.2 °C degrees warmer than the 1997 log, most likely because of calibration differences (see Figure 4). This small change in temperature at 2190 ft bls may

Figure 4. Well UC-1-P-2SR temperature log comparison of 1997 and 2021. (The upward log is shown for August 2021).
