2016 Postclosure Groundwater Monitoring and Inspection Report, Central Nevada Test Area, Nevada, Subsurface Corrective Action Unit 443

December 2017

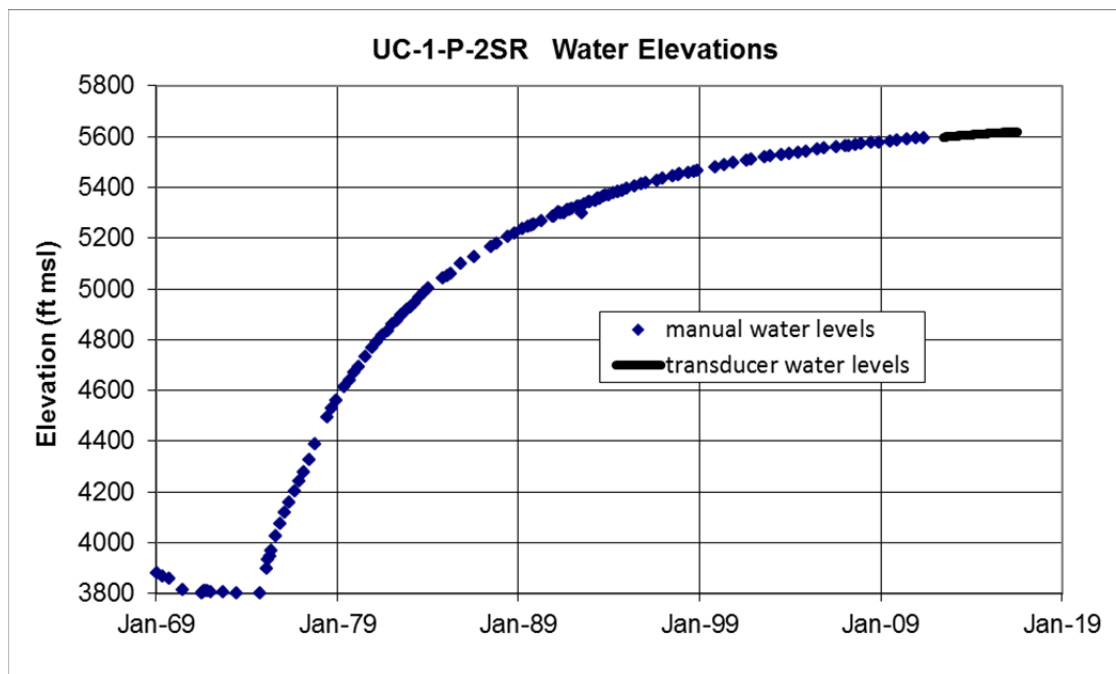
Figure 5. Water Elevations in Reentry Well UC-1-P-2SR
http://nevada.usgs.gov/doe_nv/sitepage_temp.cfm?site_id=383806116125951

Water elevations in the volcanic sediments are highest at the detonation depth, likely due to a detonation-related pressure response. This is most evident inside the graben where the water elevation is approximately 6015 ft msl in the MV-1 lower piezometer (LPZ) that is screened at the detonation depth. The water elevations at the site suggest that the most likely flow direction from the source zone is down, toward the densely welded tuff units (elevations of about 5560 ft msl). Wells MV-1, MV-2, and MV-3 are screened in densely welded tuff units near and below the source zone. Water elevations from these wells and interpretations on the geometry of the major graben faults at these depths, suggest a flow direction that is to the northeast in the densely welded tuff units. Aquifer tests performed on the MV-1, MV-2, and MV-3 wells indicate low hydraulic conductivity values ranging from 8.5×10^{-6} to 6.7×10^{-5} m/day (Lyles et al. 2006). The low hydraulic conductivities and anomalously long water level recovery time in UC-1-P-2SR (chimney) (Figure 5), is consistent with a detonation zone surrounded by low-permeability material.

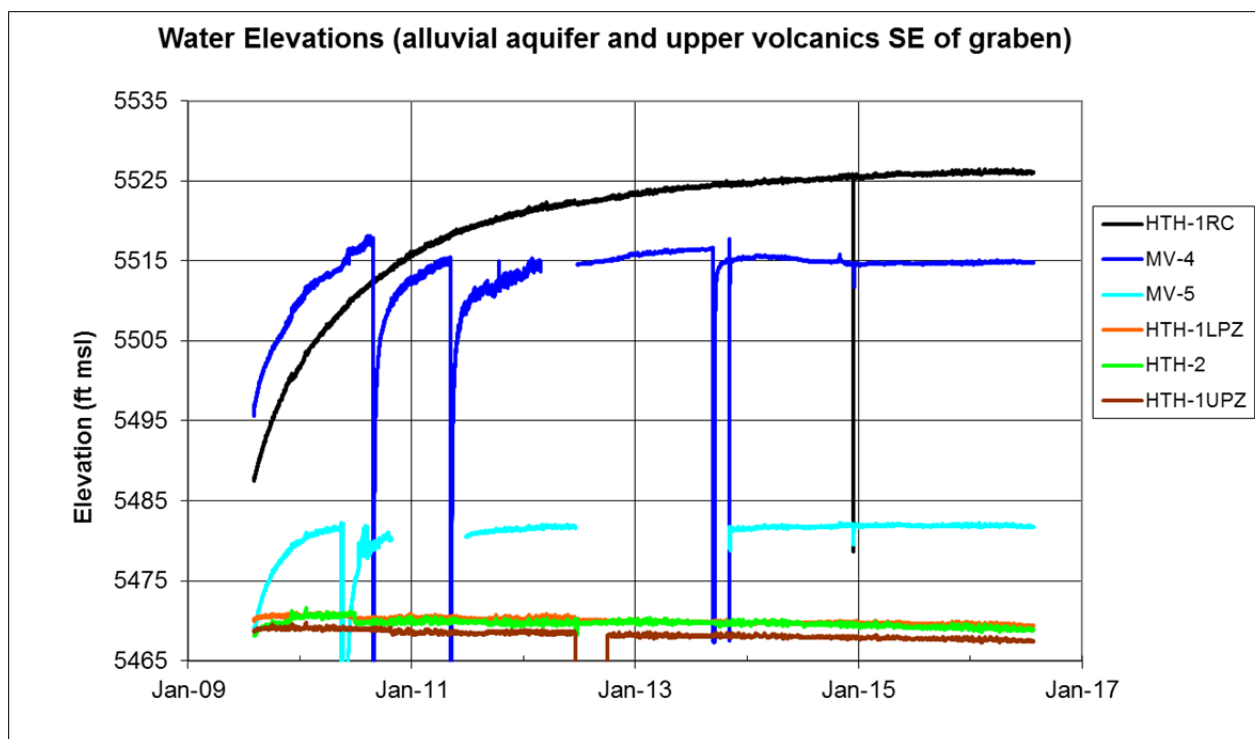
Figure 6. Water Elevations for the Alluvial Wells and Well HTH-1RC (Upper Volcanics) Southeast of the Down-Dropped Graben at the Screened Horizon

Figure 6 shows hydrographs from January 2009 through July 2016 of alluvial wells and piezometers southeast of the graben (MV-4, MV-5, HTH-2, HTH-1UPZ, and HTH-1LPZ) along with well HTH-1RC (screened in the upper volcanic section below the alluvium). These data indicate that water levels in wells MV-4 and MV-5 have only recently recovered from the 2010 aquifer testing and from the 2011 yearly sampling event during which several thousand gallons of water were purged. Low-flow bladder pumps were installed in wells MV-4 and MV-5 during the November 2013 sampling event to reduce the well purge volumes and the impact purging has on the water levels during sampling (DOE 2014). Water levels in well HTH-1RC continue to equilibrate after the recompletion in 2009. Prior to its recompletion, HTH-1 had been perforated across its entire saturated section, and its water level was a composite of several hydrostratigraphic units. The recompletion isolated zones in the upper and lower alluvium (HTH-1UPZ and HTH-1LPZ) and in the volcanic section (HTH-1RC). HTH-1RC isolated a densely welded tuff unit above the detonation depth, but the original well casing remains open below an obstruction at 2812 ft bgs (elevation of about 3200 ft msl) to the original depth of 3704 ft bgs (elevation of about 2300 ft msl), allowing contribution from the volcanic section below the detonation zone (Figure 4). The water elevation in the volcanic section (HTH-1RC) is higher than water elevations in both the upper and lower alluvial piezometers (HTH-1UPZ and HTH-1LPZ). This observation confirms that an upward gradient from the volcanic section to the alluvium exists in this area, as had been indicated by flow logging performed by Desert Research Institute in HTH-1 prior to the well's recompletion (DOE 2008). This hydrograph of water elevation is also presented in Appendix B as Figure B-1.

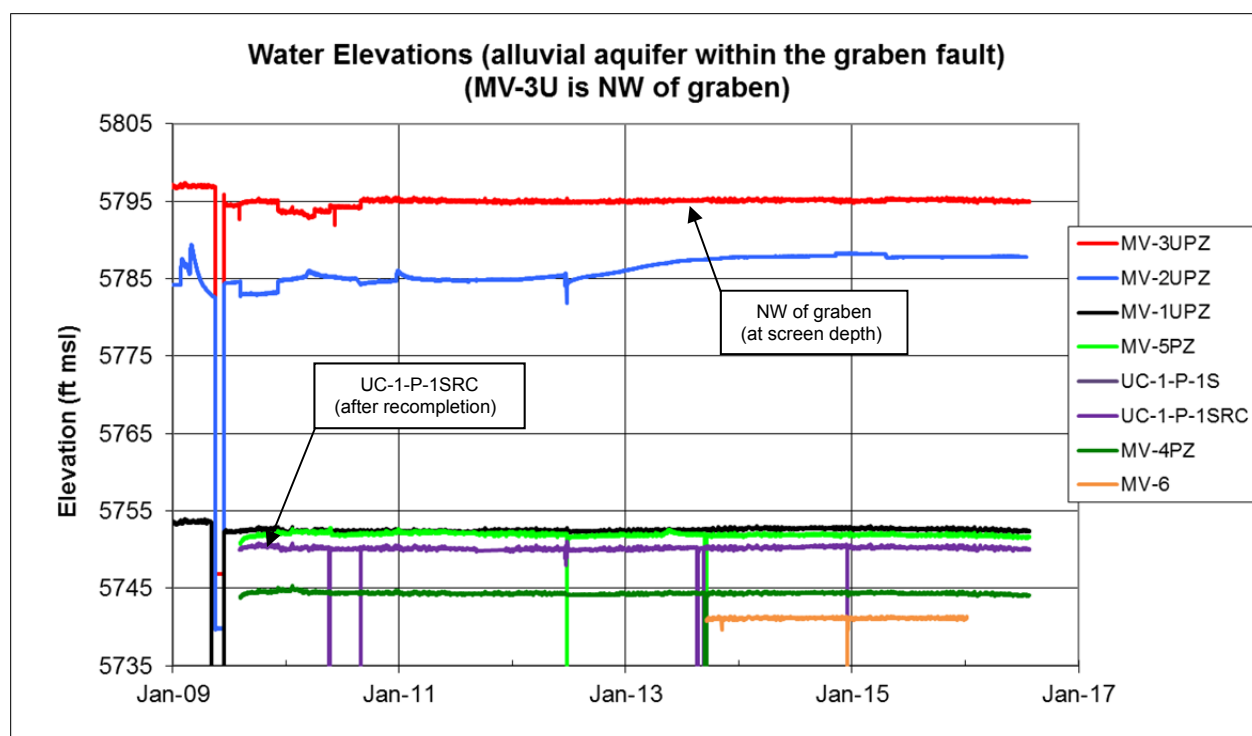
Figure 7. Water Elevations for the Alluvial Wells Northwest of the Southeast-Bounding Graben Fault

Figure 7 shows hydrographs from January 2009 through July 2016 of alluvial piezometers and wells within and northwest of the graben. Erratic water levels in upper piezometer MV-2UPZ (Figure 7) are attributed to damage during its installation. The lower water elevations observed after mid-2009 in the upper piezometers MV-1UPZ and MV-3UPZ are the results of attempts to further develop these piezometers. The recompletion of well UC-1-P-1S resulted in a screened interval about 400 ft above the previous open interval and a roughly 7 to 8 ft decrease in water elevation (Figure 7 and Figure B-2 in Appendix B). The new completion is more isolated from the influence of deeper horizons where water elevations have been higher. The water elevations in the piezometers MV-4PZ and MV-5PZ (screened inside the graben) are approximately 250 ft higher than those in the MV-4 and MV-5 wells that are screened outside the graben to the southeast (Figure 6). Given these results, alluvial aquifer hydrographs were separated into two groups based on their screened location relative to the southeast-bounding graben fault. Water elevations from the MV-4 and MV-5 wells and piezometers continue to support the conceptual model that the southeast-bounding graben fault acts as a barrier to flow. Data are not available from well MV-6 for the time period of January 2016 through July 2016 because the battery in the transducer failed and the data could not be recovered. Figure B-2 in Appendix B provides the water elevation as hydrographs from when monitoring began in 2007 through July 2016.

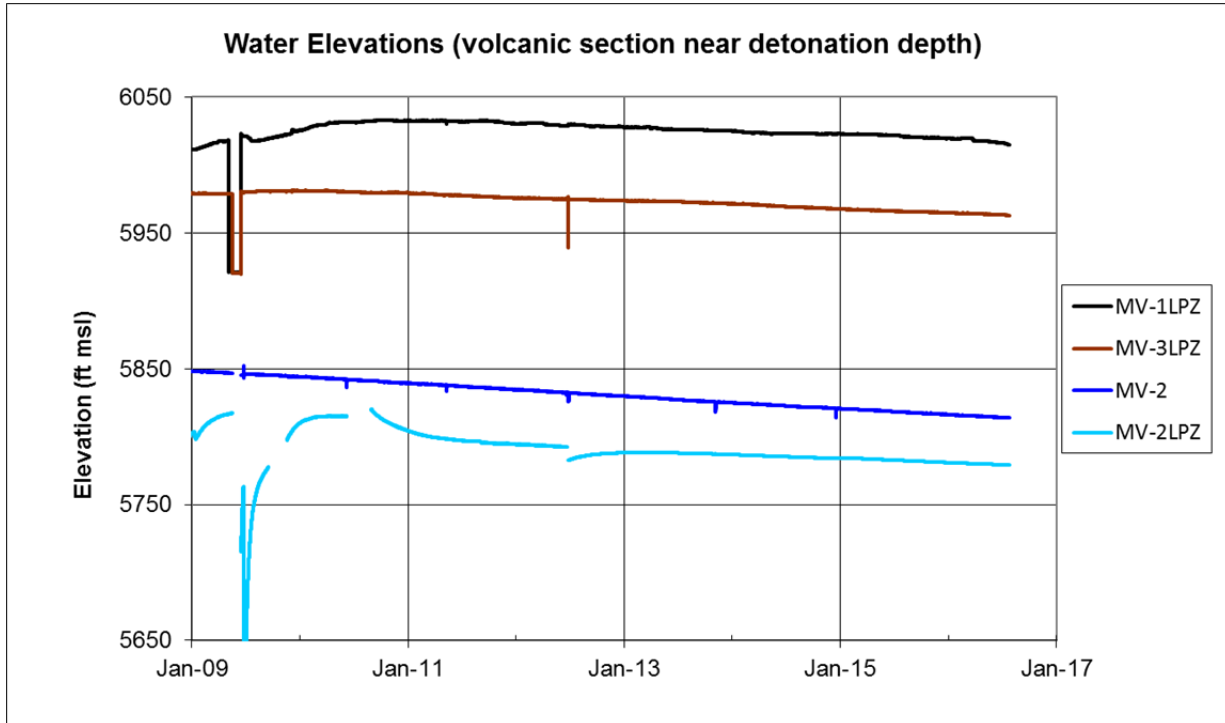
Figure 8. Water Elevations for the Well and Piezometers Screened in the Volcanic Section at or near the Depth of the Detonation

Figure 8 shows hydrographs from January 2009 through July 2016 of the well and piezometers with open intervals near the detonation depth. Water elevations in the well and piezometers at this depth have been declining since their installation in 2005 except for MV-1LPZ which had a rising water elevation after installation until 2011. Water elevations in MV-2LPZ have been decreasing at about the same rate (about 5 ft/year) as the other wells and piezometers screened in the volcanic section since 2012. The declining water elevations (highest observed in the volcanic section) are attributed to a slow release of the detonation-related pressure response that persists due to the low permeability of the volcanic section.

The highly variable water levels in the MV-2LPZ (Figure 8) were investigated by Desert Research Institute on August 5, 2008. They ran a temperature log, collected a bailed sample, and measured the depth of the lower piezometer (MV-2LPZ). It was determined that sediment had filled MV-2LPZ to a depth 75 ft above the top of the screened interval. Additional development of this piezometer in the summer of 2009 lowered the sediment fill to the top of the screened interval. Water elevations in MV-2LPZ appeared to recover in 2010 from the development, then steadily declined (at a decreasing rate) through 2011 and into 2012, when the water level dropped approximately 10 ft after well MV-2 was sampled. After this monitoring event, the water levels in the lower piezometer MV-2LPZ recovered and then reverted to a decreasing trend. The proximity of the MV-2LPZ screened interval to the northwest-bounding graben fault is believed to be the cause of its erratic water levels. It is expected that water levels southeast of this fault (within the graben) are higher than water levels to the northwest, outside the graben. The abrupt water level increase (MV-2LPZ) in June 2010 followed by an abrupt decrease in June 2012 is the result of the installation (2010) and subsequent removal (2012) of a direct-read transducer with a ¼-inch cable. The transducer was placed more than 200 ft below water in case another sudden water level drop like the one in 2008 were to occur. The slow recovery of water

levels in MV-2LPZ in response to what should be minor perturbations attests to the low permeability of the section. Figure B-3 in Appendix B provides the water elevations as hydrographs from when monitoring began in 2007 through July 2016.

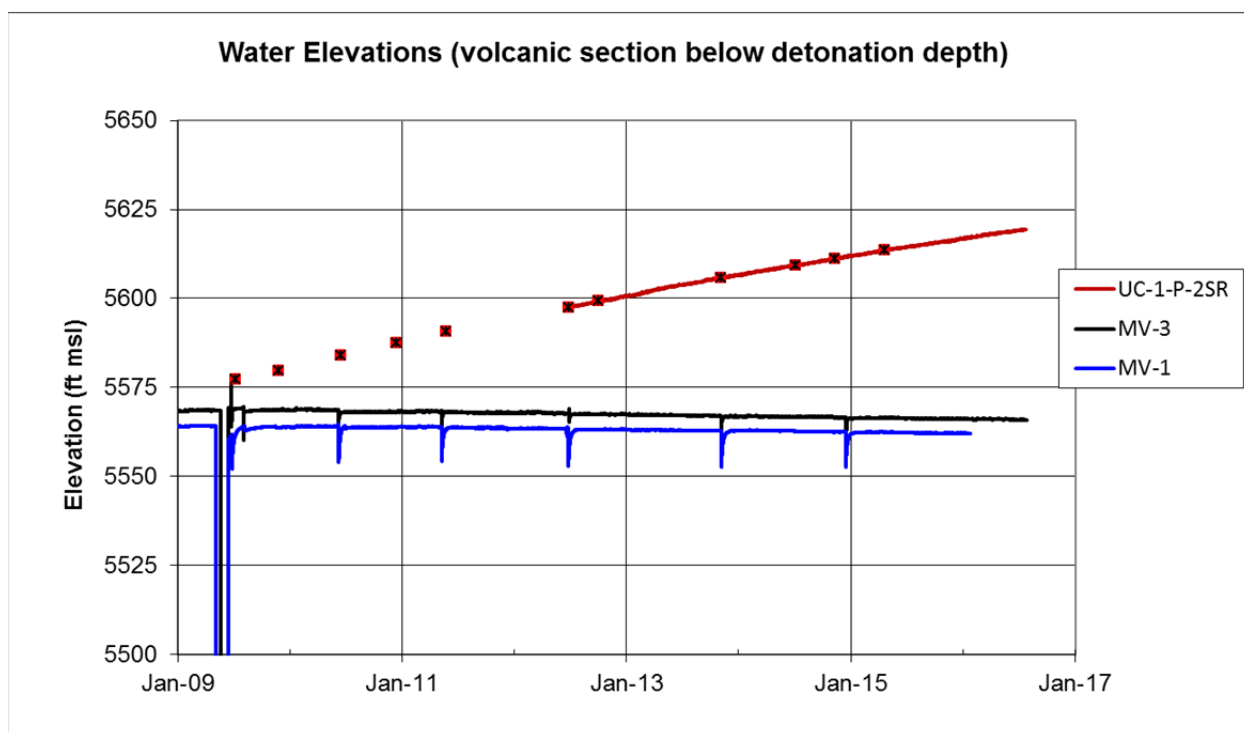
Figure 9. Water Elevations for the Wells Screened in the Volcanic Section Below the Depth of the Detonation
(Water elevations for reentry well UC-1-P-2SR [drilled into the chimney] are shown for reference.)

Figure 9 shows hydrographs from January 2009 through July 2016 of wells with open intervals below the detonation depth and reentry well UC-1-P-2SR. The composite water level from UC-1-P-2SR (chimney and alluvium overlying the former cavity) is higher than in the densely welded tuff units below the detonation zone. The composite water elevation of 5619 ft msl measured in July 2016 (Table 3) continues to increase, though at a long-term decreasing rate. Well UC-1-P-2SR has perforations as high as 1148 ft bgs in the alluvium, and its water level is expected to eventually reach a steady-state elevation of approximately 5765 ft msl (similar to other alluvial wells and piezometers within the graben). Figure B-4 in Appendix B provides the water elevations as hydrographs from when monitoring began in 2007 through July 2016.

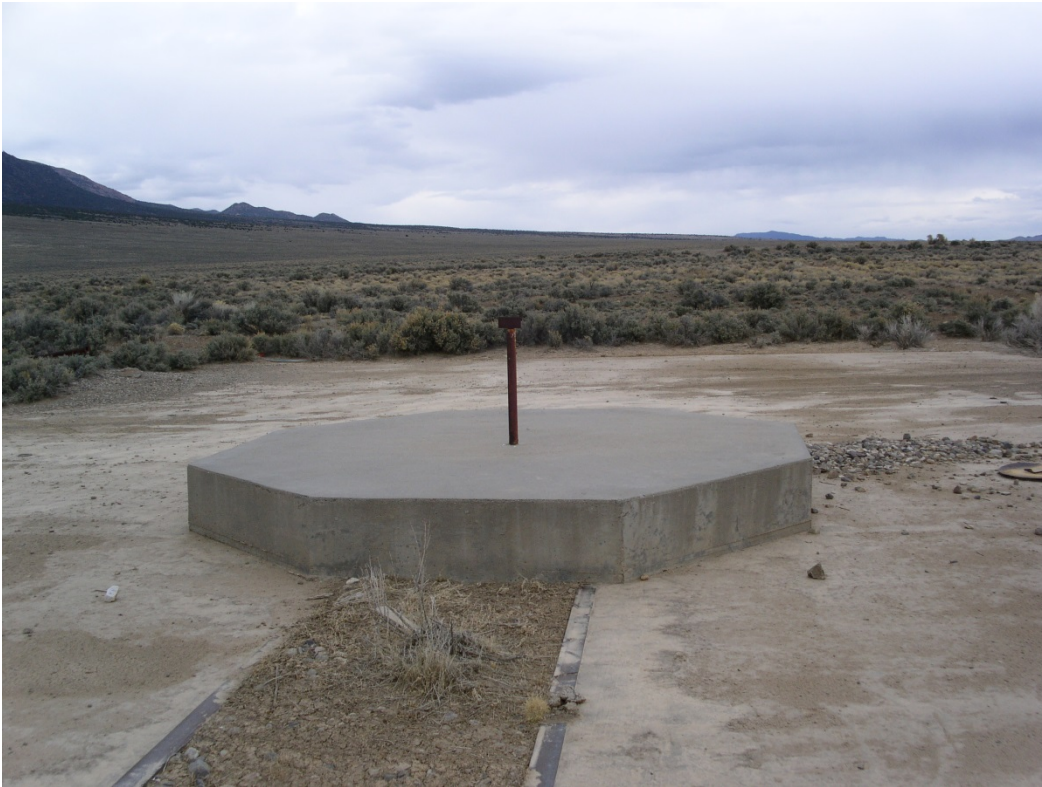
Figure A-1. Photo Showing the Concrete Cap that Covers the UC-3 Emplacement Borehole

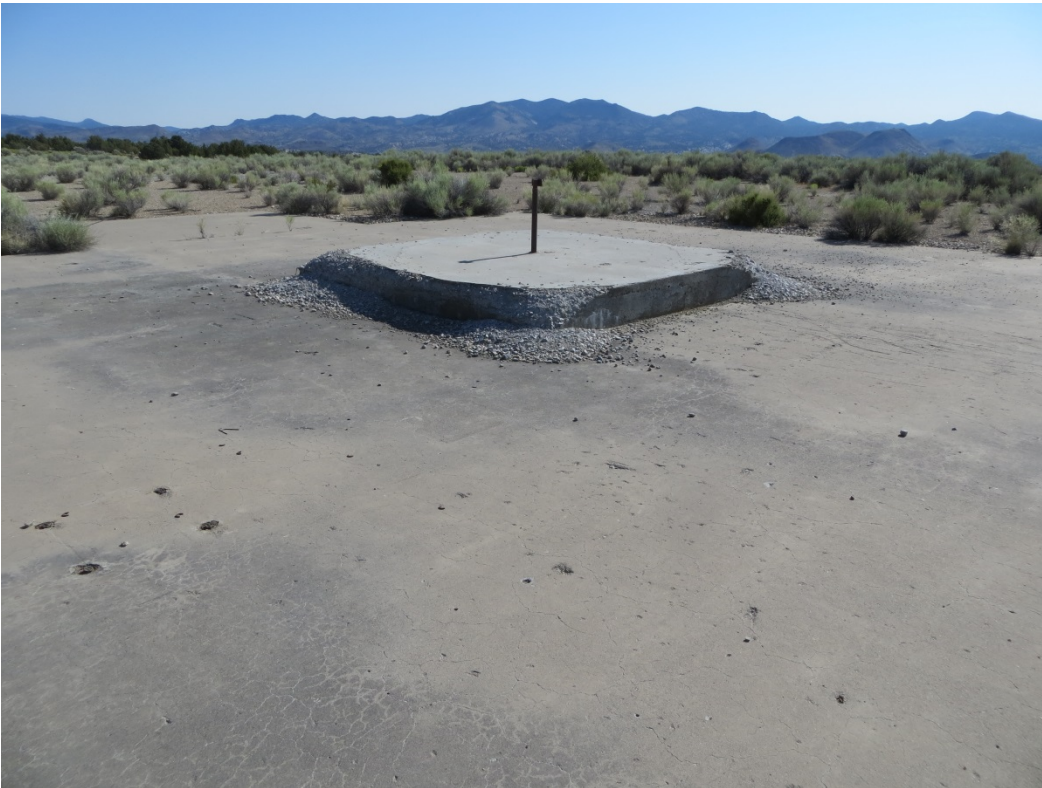
Figure A-2. Photo Showing the Concrete Cap that Covers the UC-4 Emplacement Borehole

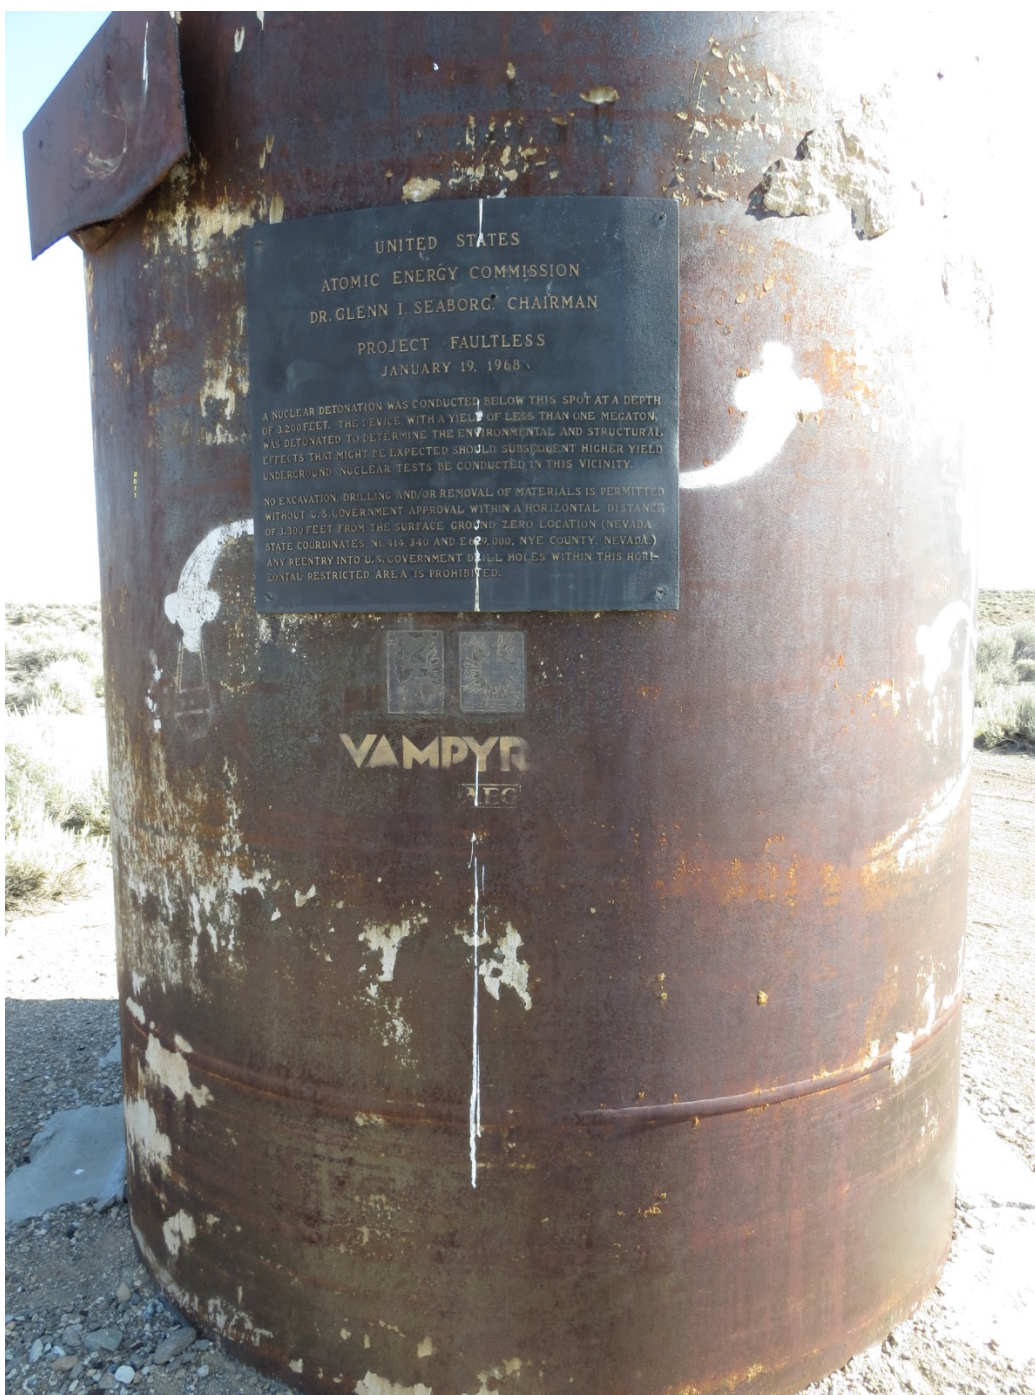
Figure A-3. Photo Showing the UC-1 Monument Plaque on the Emplacement Borehole Casing
